# LOOSE STATOR CORE DIAGNOSTIC METHODS

## SUMMARY

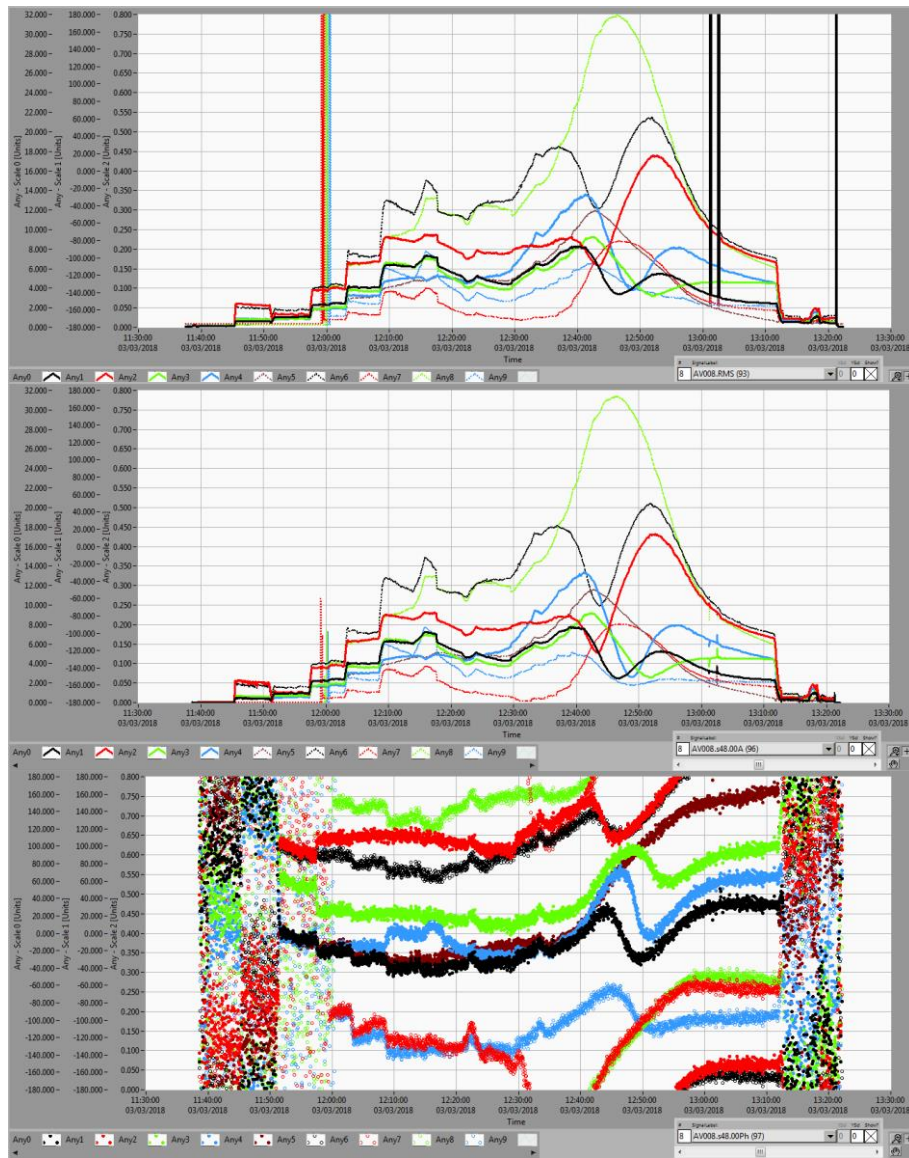
**Fig. 21 TOP: RMS of vibrational velocity. MIDDLE: 48x harmonic amplitude RMS. BOTTOM: 48x harmonic phase.**

Comparing Fig. 15 and Fig. 21 it can be seen there are similarities in vibrational behaviours. The maximum vibrations are noticed around  $\sim 43^{\circ}\text{C}$  which is somewhat higher than the temperature at which they occurred on 30.01.2017. but the vibrational behaviour shows a similar trend. After approximately half an hour the stator core temperature increases for  $5^{\circ}\text{C}$  and the vibrations decrease rapidly which is a sign that the natural frequency moved above 100 Hz.

From the trends, it is clearly seen that the vibrations are dominantly occurring on 100 Hz frequency (48x harmonic of rotational frequency) which is the frequency at which the magnetostrictive and electromagnetic forces in the windings are exciting the construction.

The resonant response time period of the stator frame and core is clearly seen as the sharp and large changes in vibration amplitudes and phases on 100 Hz frequency. This is due to the fact that there are changes in the stator frame and core vibration shapes when the system passes through resonant response.

It is possible that there is a position on the stator core on which the vibrations are larger than 31 mm/s which is the largest measured value on 03.03.2018. But, to evaluate the vibrational state and detect the root-cause the detailed identification of vibrations on different radial positions and stator core height is not necessary.

The presented results are enough to **evaluate the core as completely unacceptable and unsafe for the stator winding isolation**.

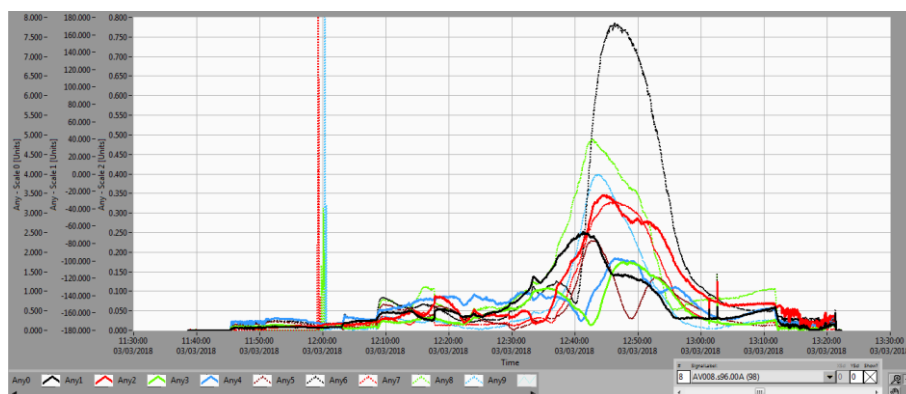
**Fig. 22 96x harmonic amplitude RMS (corresponding to 200 Hz).**

From this trend diagram, it can be seen that in the time period from 12:45 h to 12:55 h, when the vibrations are the largest on 100 Hz, they also increase on 200 Hz. It should be noted that from 12:35 h to the end of the measurement the active and reactive power didn't change, which also means that the electromagnetic forces on the stator core remained unchanged.
