VIBRATION DIAGNOSTICS AND OVERHAUL PROCEDURES IN HPP JAJCE 1

Problems related to large vibrations were observed in Jajce 1 Hydro Power Plant on Unit 1. Extensive vibration measurements were conducted with the purpose of providing clear guidelines for the unit overhaul. Vibration was monitored in all relevant operating regimes.

Two Francis turbine powered hydro units, 31 MW each are installed in Jajce 1 Hydro Power Plant. Net head is 92.5 m and the rotational speed 300 rpm with the 37 m³/s flow per unit. Very large vibrations have been noticed on Unit 1. For this reason – measurements to reveal the vibration root causes have been performed and adequate overhaul procedures suggested. Accurate measurement results interpretation and problem diagnostics are of crucial importance for successful overhaul works to reduce the unit vibrations.

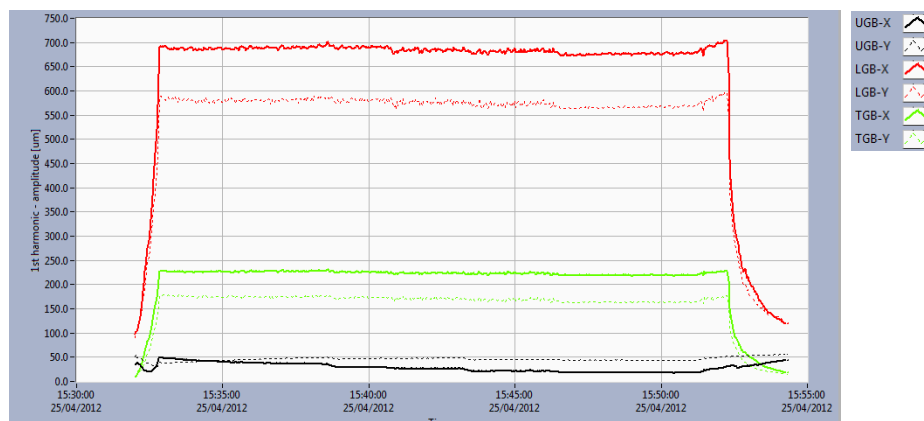
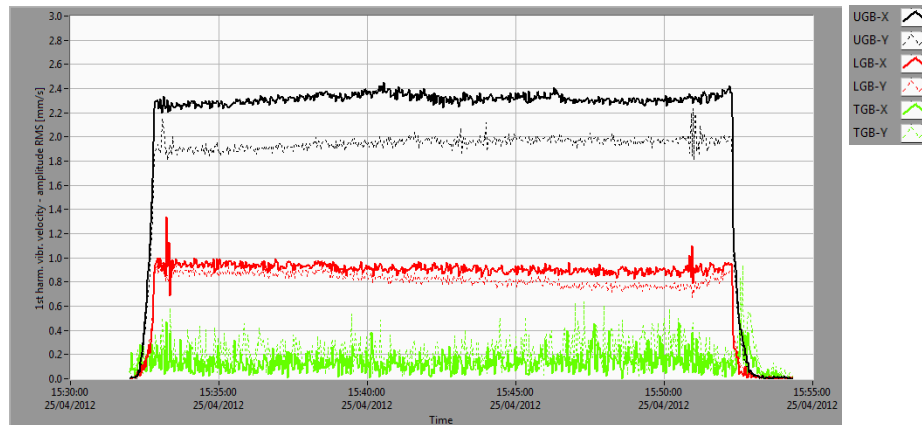
Fig. 5 Upper diagram: Trend of first harmonic peak amplitude for shaft displacement. Lower diagram: Trend of first harmonic rms amplitude for bearing housing vibrations.

From Fig. 5 it can be seen that the LGB relative vibrations in both directions X and Y are outside the allowed values recommended by the standards (ISO 7919-5:2005 – see Fig. 6) and also outside the one-sided clearance which is set to ~0.22 mm. For example – the boundary between zones C/D¹ for 300 rpm machines is at 270 μm and the amplitude peak vibrations on LGB are above 700 μm ! It would be very dangerous to run this machine for a longer time as it could lead to its catastrophic failure.

The shaft displacements relative to the bearing housing at UGB are very small (black lines on Fig. 5 – upper diagram), but at the same time the bearing housing absolute vibrations at UGB are between 1.9 and 2.4 mm/s (these are the first harmonic rms values, that is values at 5 Hz) depending on the direction viewed. This indicates shaft tension in the UGB zone where the forces are transferred through the oil-film to the bearing housing. If the shaft was in the bearing center – for measured displacements – the vibrations on the bearing housing would also be small, especially at the first harmonic. This is not the case here.

Since the displacements on LGB are larger than the bearing clearance and vibrations on bearing housing are relatively small (under 1 mm/s for amplitude rms of the first harmonic of the vibrational velocity) one can conclude that the large forces between the shaft and the LGB segments have 'widened' the LGB clearance due to the fact that the shaft created extra space to vibrate within. Such a situation produces a great stress on the LGB construction. Housing vibrations are not as large since the LGB construction is very stiff and these forces are (through the LGB construction) transferred directly to the foundation.

Such a disproportion between the displacements and absolute vibrations of bearing housing on UGB and LGB suggests there are also problems with the fact that **shaft and bearing are being misaligned**.

Based on these measurements – basic overhaul procedures were proposed to improve the unit's vibrational state. When the unit was stopped before the (first) overhaul, it was found that LGB bearing was damaged and that the one-sided clearances were increased to ~0.5 mm when compared to the nominal values (~0.22 mm). Overhaul was performed in 2012. During this overhaul, the LGB was repaired and set to its nominal (~0.22 mm – one sided) clearance. But, unfortunately – the problem of forces originating from the rotor was not solved by these actions as the state begun to deteriorate (vibrations started to increase). New measurements were performed with the purpose to solve unit's vibrational problems once and for all.

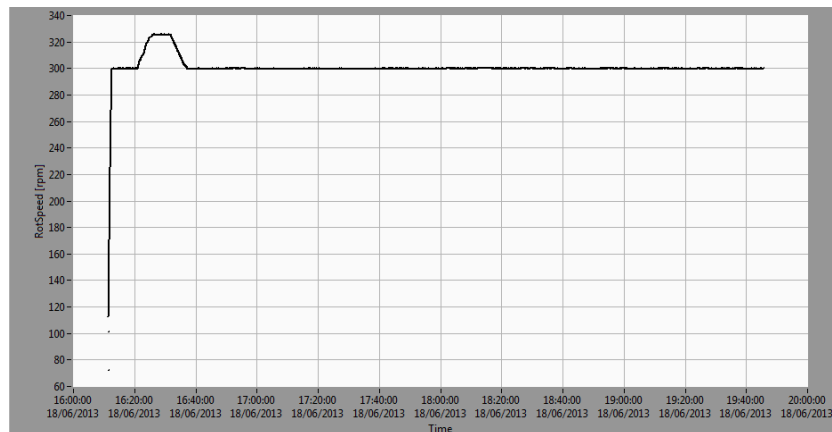
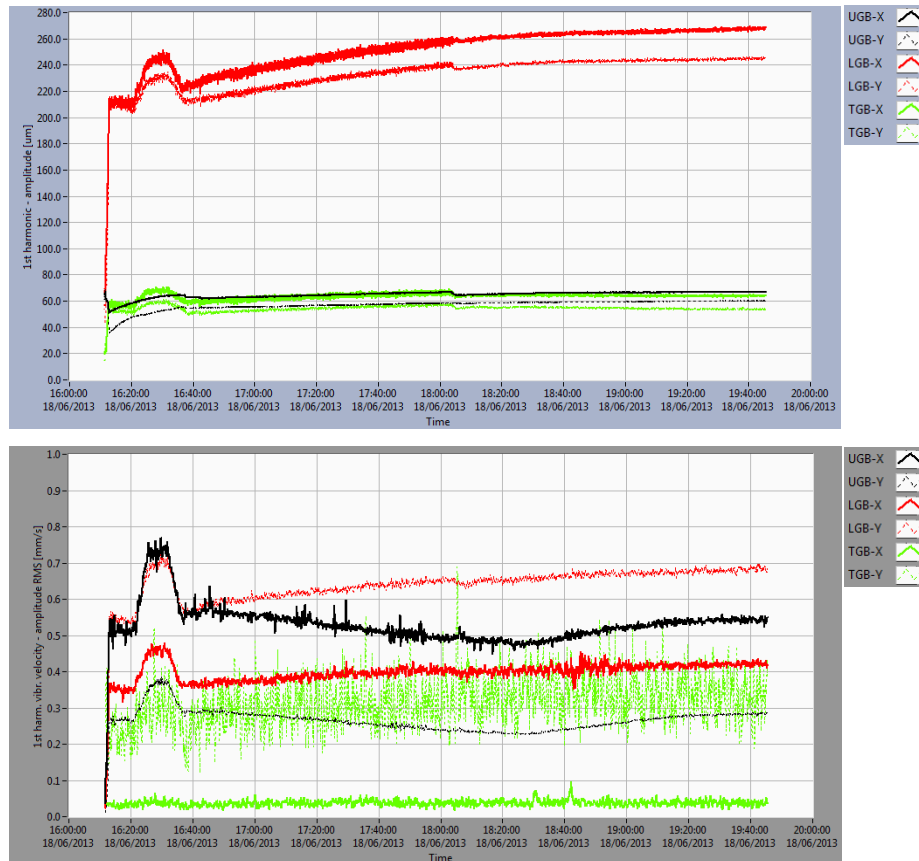
Fig. 7 Rotational speed trend during the measurements (upper diagram). Trend of first harmonic peak amplitude for shaft displacement. UGB-X and UGB-Y at the position above thrust collar, below slip rings (middle diagram). Trend of first harmonic rms amplitude for absolute vibrations (lower diagram).

First of all – it can be seen that the vibration amplitudes change significantly with the regime changes, especially for LGB vibrations, which are at the limit of allowed values even for short-term operation (according to ISO 7919-5 the C/D zone limit is $\sim 270 \mu\text{m}$). At the beginning of the recording, the amplitudes peak of the first harmonic (which are practically identical to S_{max}) reach $\sim 210 \mu\text{m}$ on the LGB. Unit was already automatically excited at this point. After that, for a short time – the rotational speed was increased to $\sim 330 \text{ rpm}$. Vibrations increased to $\sim 250 \mu\text{m}$ thus indicating that they vary significantly with the regime changes.

It can also be seen from the diagrams that the vibrations for rotation with excitation and later with load increase continually. After approximately 4 hours they reach $\sim 270 \mu\text{m}$. It

can be evaluated that they would, after approximately, 2 hours reach 280-290 μm . Those numbers are unacceptable for the long-term operation. The vibrations on UGB and TGB are a couple of times smaller and do not vary as much with regime changes (except rotational speed change).

One interesting fact can be seen from the diagrams. For similar absolute vibrations measured on bearing housings (0.4-0.6 mm/s) the amplitudes of UGB and LGB relative vibrations are significantly different, that is, the ratio LGB/UGB is ~ 4 . If the nominal clearances for UGB and LGB were set to similar values during overhaul, it is evident that after the overhaul the bearing clearance on UGB is significantly smaller than that on LGB which is why on UGB the relative shaft vibrations with the same values cannot develop with the same values as on LGB. It can be concluded that the shaft is „leaning“ to the one side and on this side – the bearing clearance is significantly smaller. Due to this – the oil film stiffness is significantly increased and the vibration amplitudes are smaller. So, similar to the state from April 2012, the **shaft and bearing misalignment** problem remains.

But, during the unit thermal expansion, the relative vibrations increase (Fig. 7 – middle diagram). This is a sure sign that the forces are accumulated inside the generator rotor due to which the vibrations reached the highest values allowed by the bearing clearance.

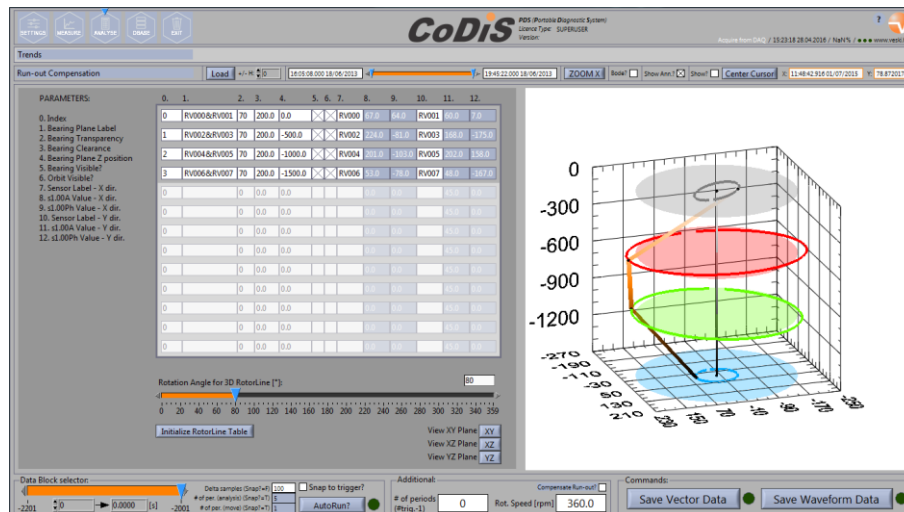
Fig. 8, basically, shows the rotor vibration shape at the rotational speed. Vibration amplitudes and phases, based on which the figure was drawn were taken for the nominal speed + excited regime. It should be pointed out that the rotor dynamical line is similar in mechanical rotation but with smaller vibration amplitudes.

Fig. 8 Rotor dynamical line (under excitation). Top to bottom: position I, position III (as indicated in text), LGB, TGB plane.

- the largest statical (DC) shaft deflection is at the coupling level and is, approximately, 80 μm ; at UGB (at bearing segments level) and at TGB – are the positions with smallest statical deflection

- the dynamical shaft deflection up to nominal (and higher) rotational speeds increases in one direction, which is seen from the phase relations
- large shaft vibrations below thrust collar, which are out-of-phase to those above the thrust collar indicate that there is a clearance between the shaft and the collar

In July 2013 an overhaul was performed during which:

- adequate (solid) connection was established between the thrust collar and the shaft (by repairing the thrust collar)
- horizontality of the thrust collar's runner was ensured
- shaft's tension in the UGB zone was relaxed
- unit was balanced (weights in the LGB plane are shown in Fig. 9)

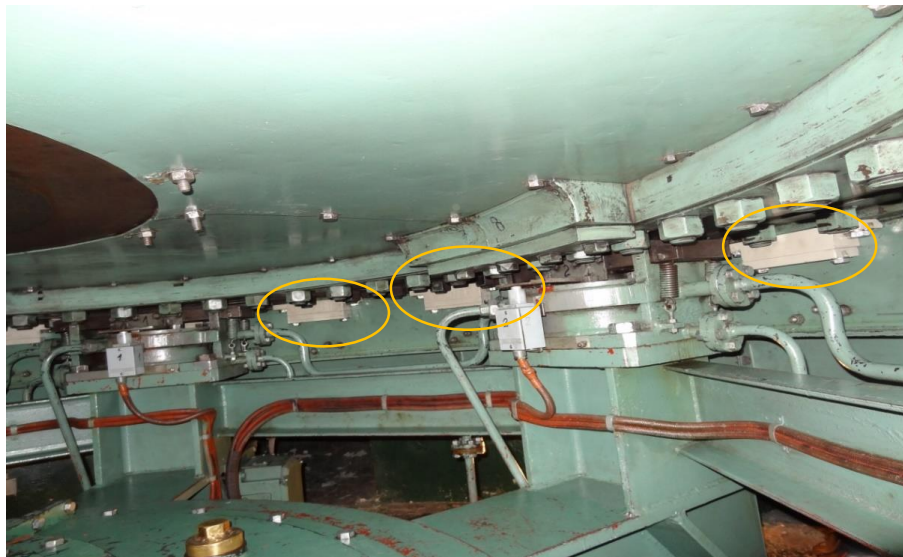
Fig. 9 Balancing weights under the generator (in the LGB zone)

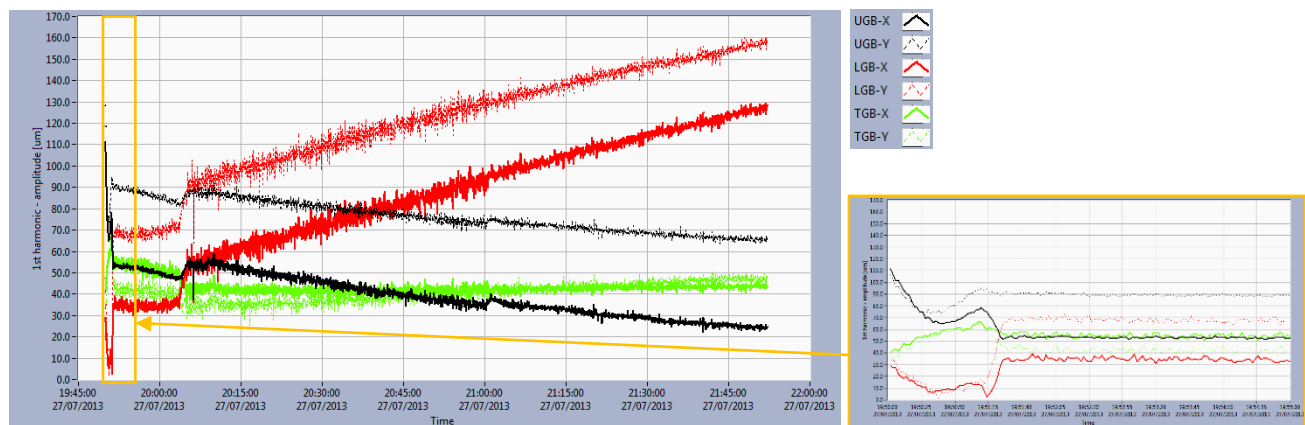
Fig. 10 Trend of first harmonic peak amplitude for shaft displacement. Small figure is zoomed in figure to compare the vibrations in mechanical rotation to that in excited state.

From the zoomed in part of the Fig. 10 it can be seen that the vibrations in mechanical rotation are significantly reduced. For example, on LGB they are 10-15 μm . After the excitation is turned on, the vibrations in the LGB-X direction increased to 35 μm and in the LGB-Y direction to 70 μm . Those are acceptable values and if they remained at these levels at maximum load – the problem with vibrations would have been solved already.

Unfortunately, after synchronization and load increase to 20 MW the vibrations increased to 60 μm in the LGB-X direction and to 100 μm in the LGB-Y direction and within the next two hours continuously increased further. After approximately one hour (around 21:00 h) the load was increased to 29 MW which had no influence on the vibration trends. The trend slope indicates that the vibrations would saturate at ~190-200 μm .

This is unacceptable and, in order to ensure that the unit operates within acceptable vibration limits, it is necessary to re-distribute the influence of excitation and thermal rotor deformations so that in all regimes the values are around 100 μm (50% of bearing clearance). This was achieved with adequate balancing weights distribution.

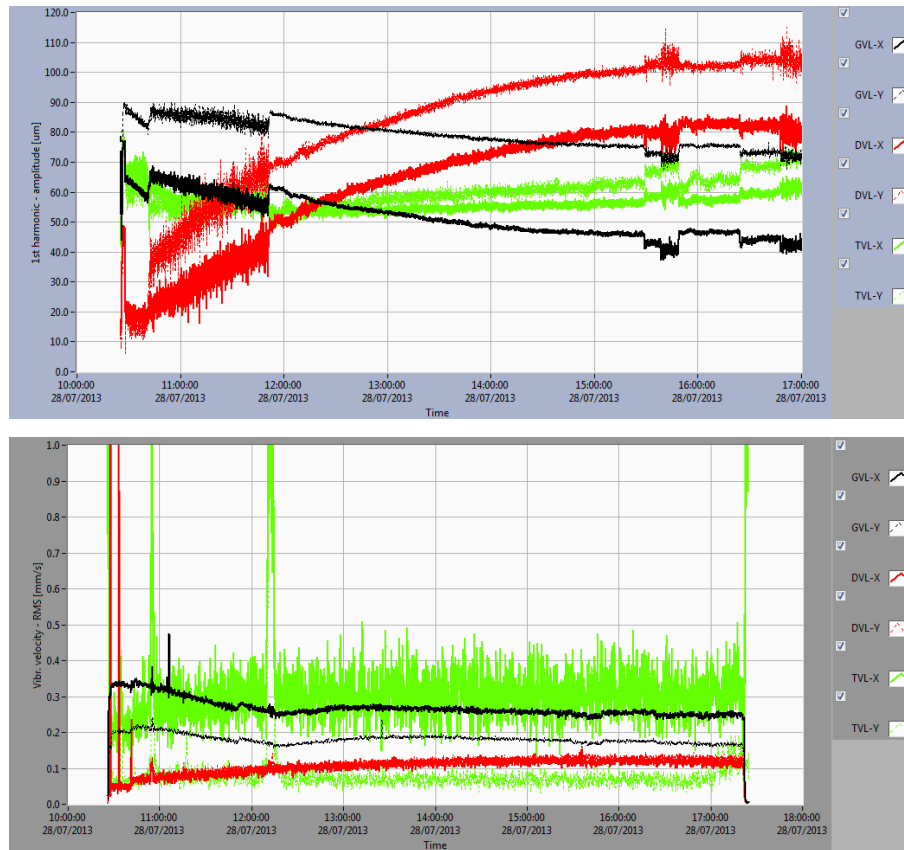
Fig. 11 Trend of first harmonic peak amplitude for shaft displacement (upper diagram). Trend of effective (RMS), that is, overall vibration velocity (lower diagram).

It's seen that the vibrations in all regimes are under 100 μm , at ~50% of bearing clearance (and absolute vibration RMS levels are under ~0.4 mm/s). A relatively large rotor run-out at UGB position is a consequence of the fact that the rotor is deformed, which was present in the same form before the overhaul. But, since the connection between the thrust collar and shaft was not rigid it diminished this deformation at UGB zone. When the connection between thrust collar and shaft was corrected in the overhaul, the run-out manifested itself fully.

Absolute bearing housing vibrations shows that after the overhaul, forces originating from the shaft and transferring to the stator and foundation were reduced multiple times when compared to the state before the overhaul.
