## HYDROGENERATOR LOOSE RIM DETECTION

### SUMMARY

This paper examines a hydro generator where a loose rim problem was identified after refurbishment work that included changing the rotor poles, as well as incorporating additional sensors to the condition-based monitoring system. This condition was identified using data from air gap and flux monitoring collected in various modes of operation. Analysis of the system database revealed that the generator often goes to over speed (up to 150% of rated RPM) putting the rotor under significant stress and could lead to more severe rim loosening or even worse – cracks in rim segments. Therefore, on-line continuous monitoring and data analysis is very important to ensure machine safety. This paper describes the data interpretation, problem identification, as well as the recommendations for future activities related to machine condition monitoring. The severity of faults that occur due to air gap problems was experienced in a small plant where a stator and rotor rub caused significant damage to both the stator and rotor.

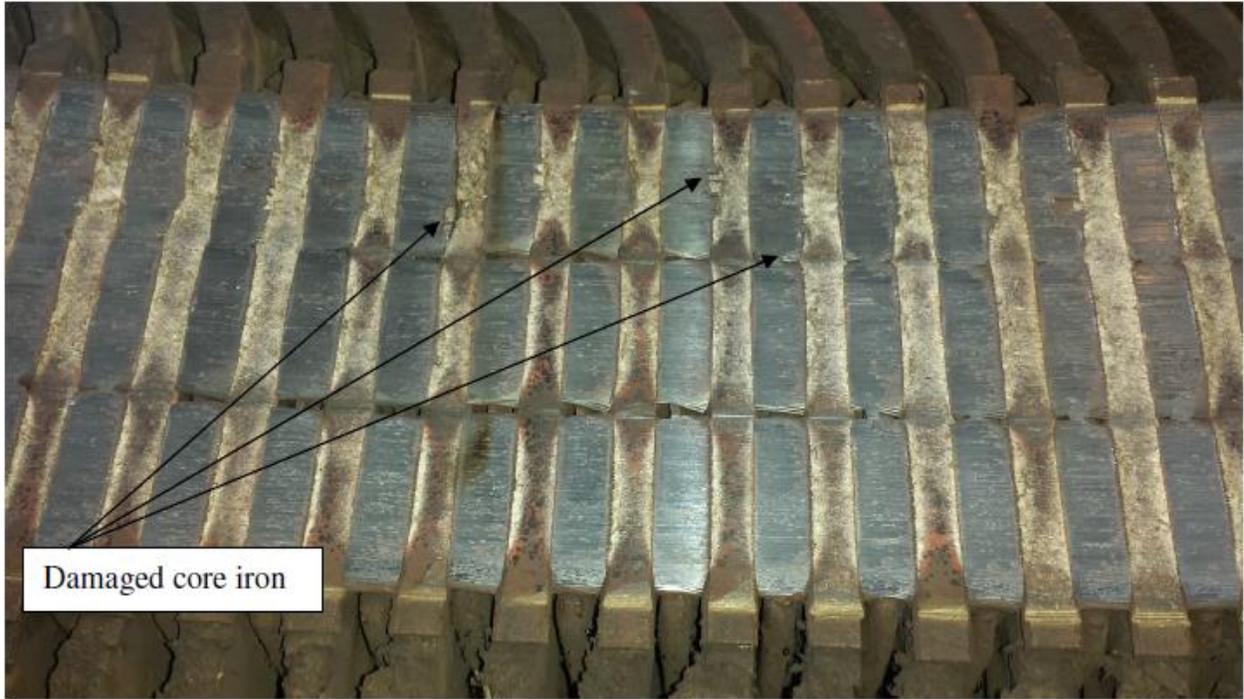
The rub occurred due to bearing failure and resulted in the formation of inter-laminar short at the impact location. Most of the pole faces of the field pole pieces also had some iron damage and overheating due to contacting the stator core. There was extensive damage to about a quarter of the stator wedges. There was a heavy coating of metals shavings and carbon dust contamination on the field rotor poles, the stator windings and the stator core.

Figure 2. Mechanical damage to the laminated core iron

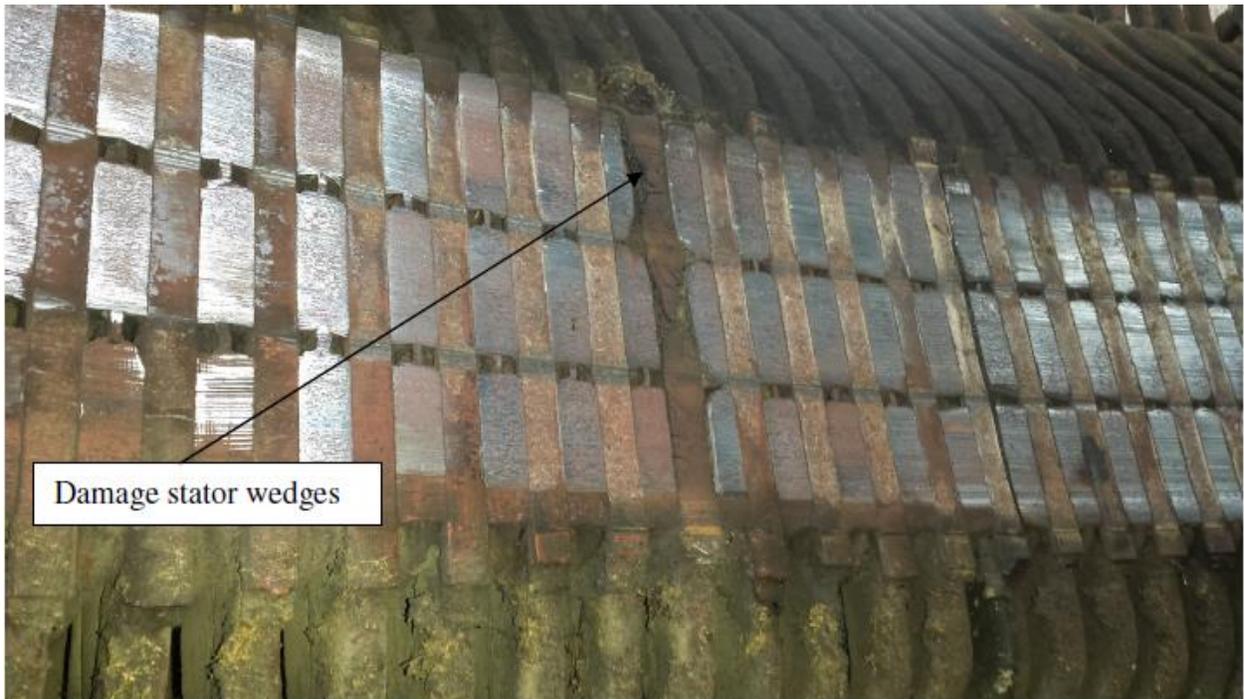
Figure 3. Damaged stator core iron and wedges

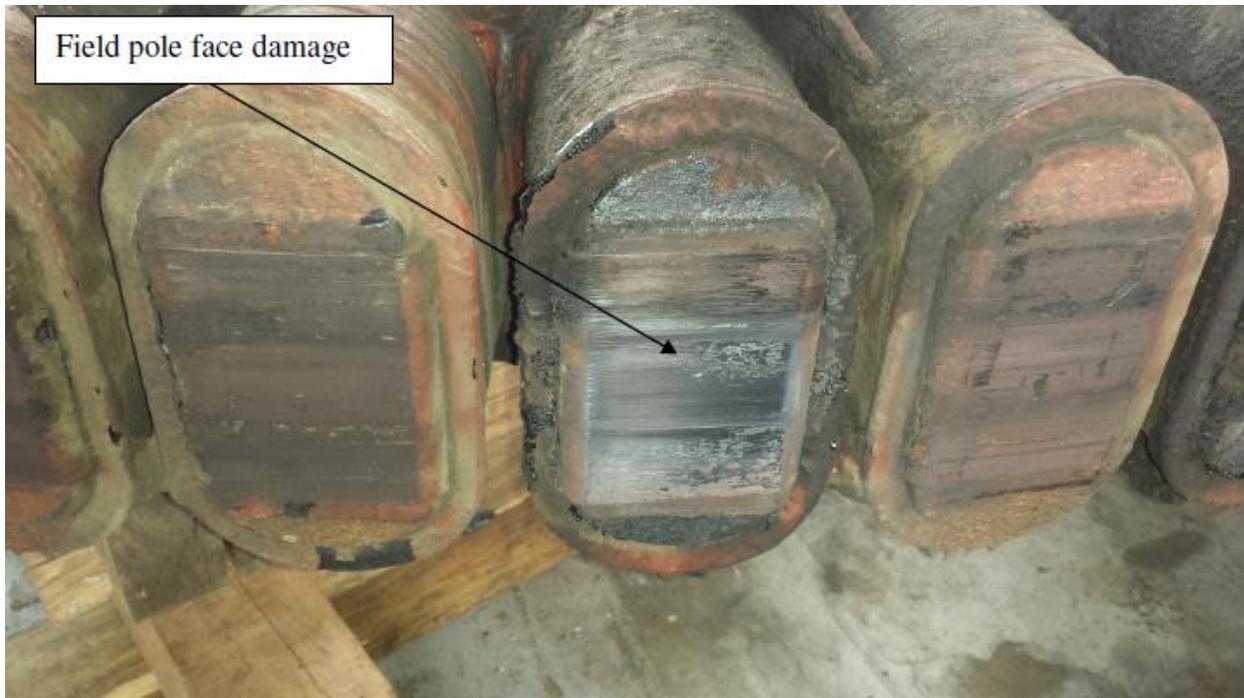
Figure 4. Mechanical damage to field pole face

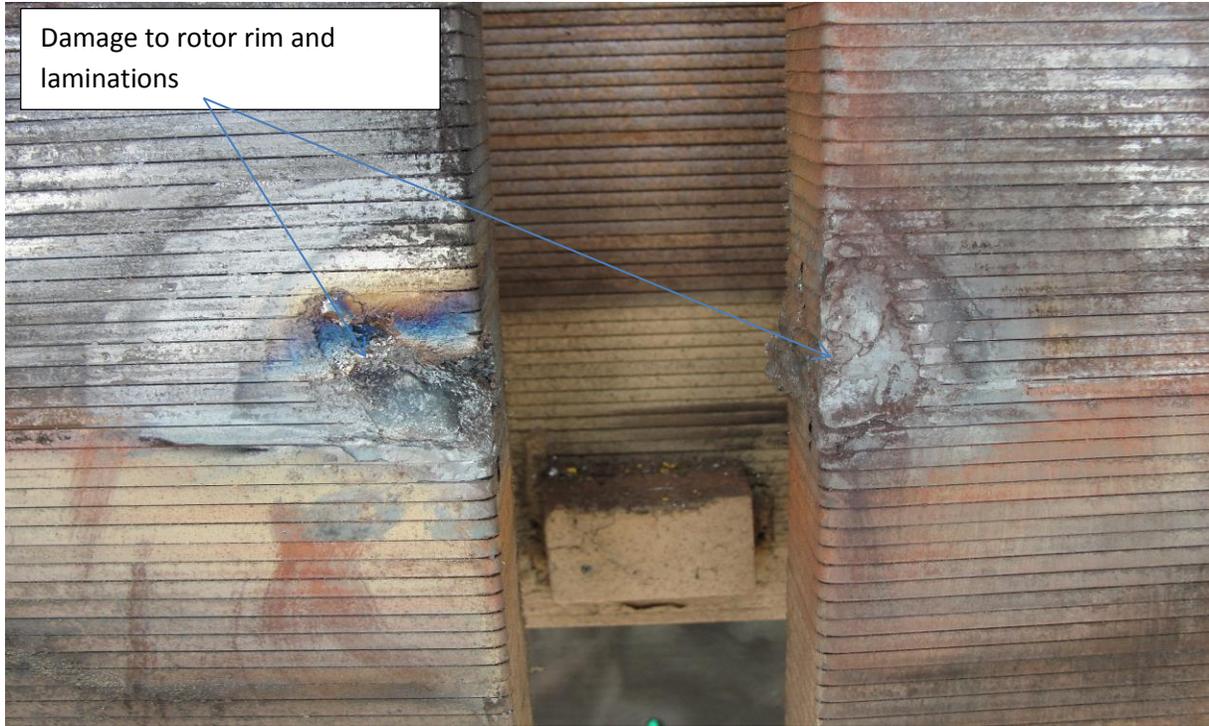
During the rewind outage, all 72 field poles of unit B were removed from the rotor rim for inspection and rehabilitation. The contractor field services personnel experienced difficulty in removing the field poles due to galling of the field pole keys and damaged laminations. There was evidenced of significant heat damage to the poles, particularly in the damper winding and lamination in the T-tail regions.

Figure 5. Damage to rotor rim and laminations

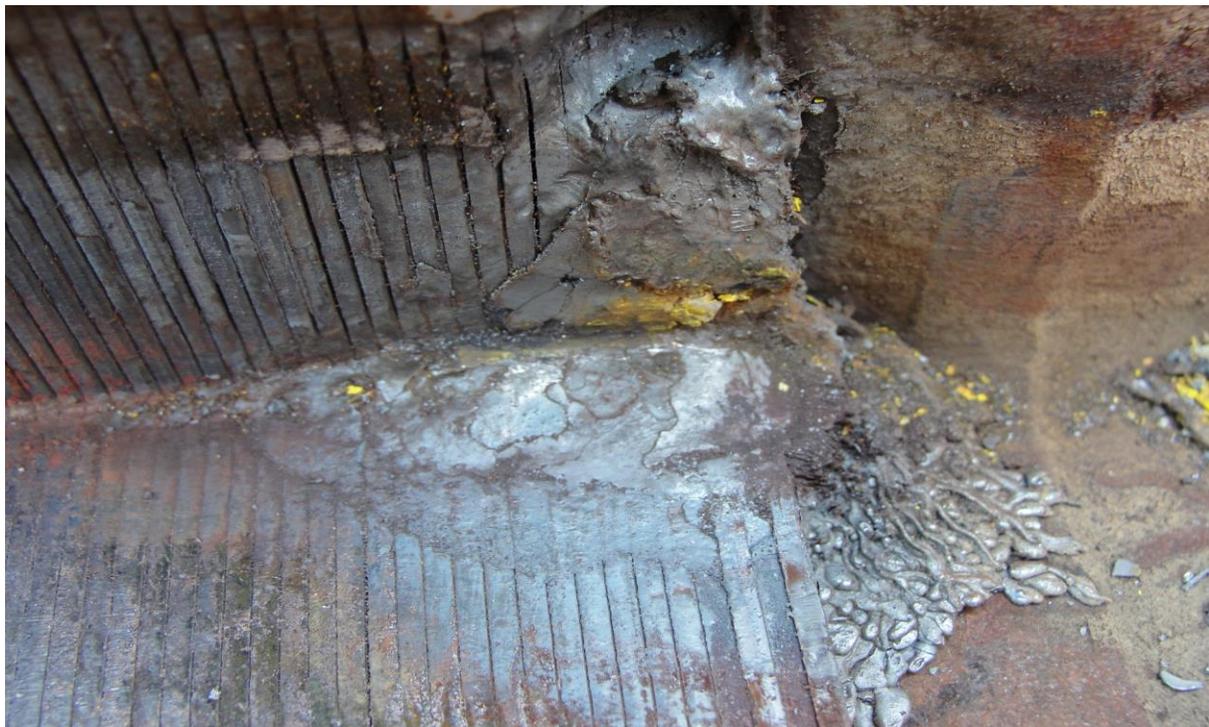
It was known that this unit had experienced a motoring event in 2008, during which the poles might have been subjected to rotating magnetic field of the stator. The event might have lasted several minutes, during which high currents might have been induced in the damper windings. After the fault in 2008, the rotor and stator passed maintenance electrical tests and was return to service.

Figure 6. Melted field poles laminations

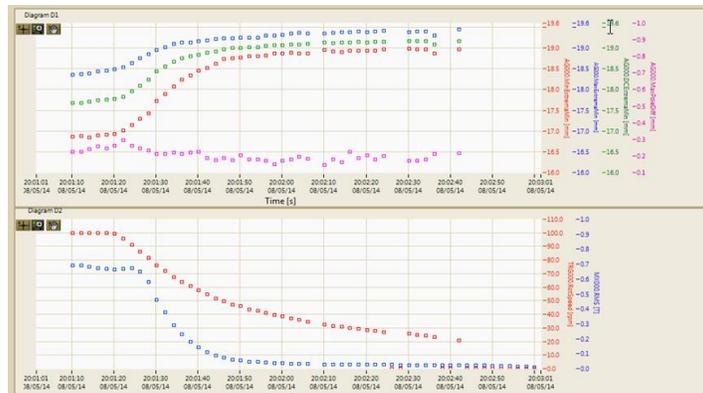
Preliminary analysis on Unit B showed a difference between the Maximum and Minimum air gap value on each sensor at 100 RPM and 20 RPM. Figure 7 shows this difference between the minimum and maximum value changing with the speed. During the transient, the difference between these two values changed from 1.5 mm to 0.5mm on both sensors indicating that the rotor geometry changed significantly with centrifugal (and magnetic) forces causing rim deformation.

Figure 7. **Unit B** Coast down Upper diagram – AGmin (red), AGmax (blue), AGmean (green), AGmax.diff (purple) in mm for AG000; Lower diagram – rotational speed (red) in rpm, magnetic flux (blue) in T

Figure 7 shows the trend values (condition vectors) at sensor AG000 (position 0° downstream) which points to uneven changes in the air gap during the coast down event.

The difference between these two values change from 1.5 mm to 0.5mm during the coast down indicating that the rotor geometry changed significantly with the centrifugal (and later with magnetic) forces causing rim deformation. The conclusion was that the radial stiffness of the rotor body (rim or pole joints) was not symmetrical. For comparison the same values recorded during a coast down event on unit A in Figure 8 shows no indication of similar problems.

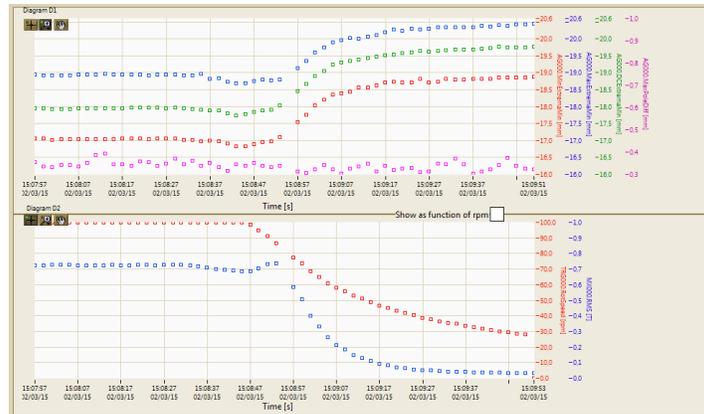
Figure 8. **Unit A** Coast down Upper diagram – Agmin (red), AGmax (blue), AGmean (green), AGmax.diff (purple) in mm for AG000; Lower diagram – rotational speed (red in rpm, magnetic flux (blue) in T

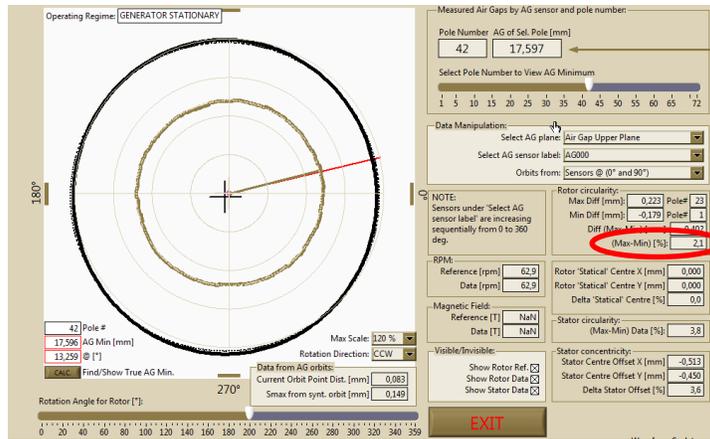
The rotor shape in Figure 9 shows that the rotor circularity was 2.1% and the shape was circular. At 100 RPM (Figure 10) the centrifugal forces started to stretch the rim. The rim distortion due to this stretch was more apparent in one direction than the other. The circularity offset was 5.9%. The major axis of the ellipse was in the direction of poles 32 to 68 and the small axis was in the direction of poles 15 to 51. Additional distortion was visible in the same direction (poles 32 to 68) in Figure 10 (full load) and the rim stiffness continued to decrease in the same direction.

Figure 9. 60 RPM, unexcited - Polar plot of rotor and stator geometry from all air gap sensors simultaneously

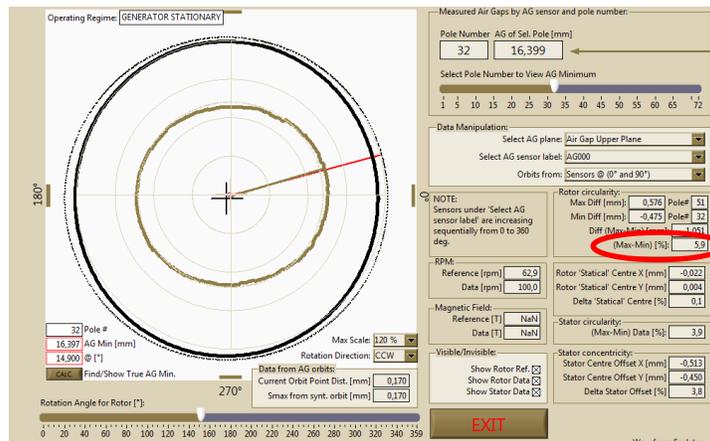
Figure 10. 100 RPM, unexcited - Polar plot of rotor and stator geometry from all air gap sensors simultaneously

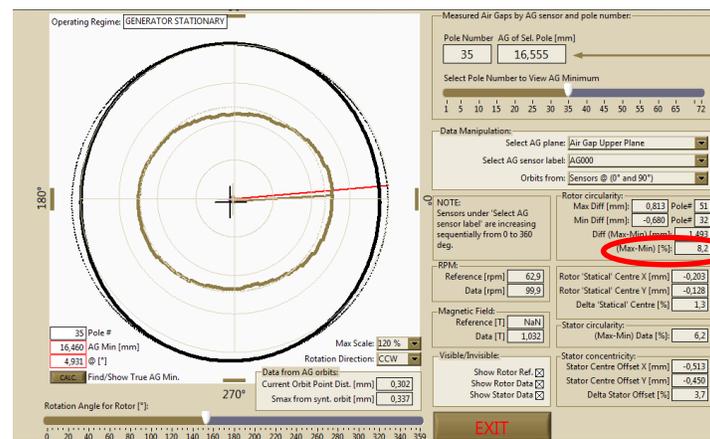
Figure 11. Full load - Polar plot of rotor and stator geometry from all air gap sensors simultaneously

Following industry guidelines [2] adapted for dynamic measurements the tolerances for rotor circularity should not exceed 6%. Unit B at full load steady state was 8.2% and outside of this guideline. This further illustrates that the radial stiffness of the rotor body was not symmetrical.

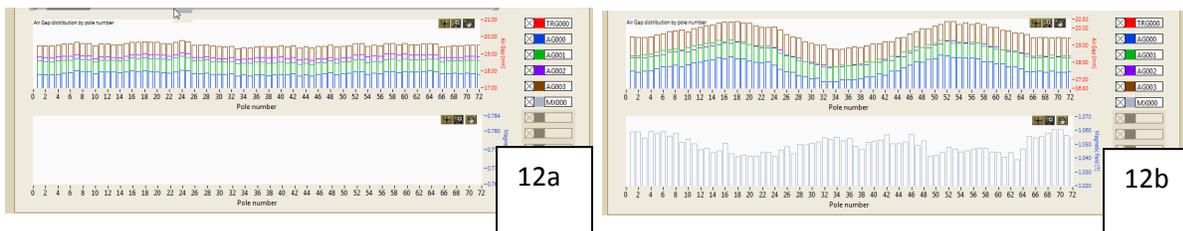
The upper diagrams in Figure 12 represent the air gap pole profiles at the operating regimes listed above. The lower diagrams represent the magnetic flux pole profile. Note that when the generator is at free run (Figure 12a) it is unexcited and there is no field, thus the pole profile is empty. The ovality of the rim is shown here with two maximums over one turn. It would represent a 2x (second harmonic of nominal speed) component of the air gap signal. This component can be tracked in real time and the alarm value can be set on it which will indicate further rim loosening.

Figure 12 – Air gap and flux pole profile through different regimes  
 - 12a - Free run 60 RPM; 12b - 100% of load

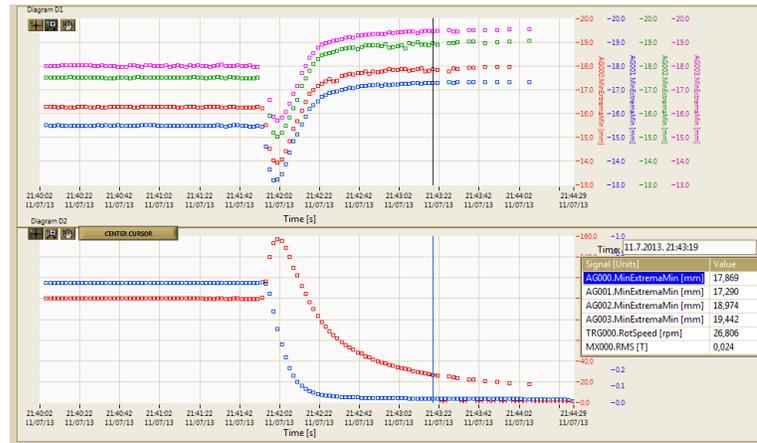
The data recorded over a period of one year on unit A revealed that several load rejections occurred where the speed increased up to 150% of nominal speed (150 RPM) significantly increasing the centrifugal forces. Over speeds like this can eventually lead to a loose rim. Figure 11 shows the rim distortion in over speed. It represents the minimum air gap values on each of the 4 sensors. The lower diagrams show RPM and Magnetic field and the upper diagrams show the Minimum air gap on all 4 sensors.

The air gap decreased under centrifugal forces by a maximum of 2.3mm (average value over 4 sensors). Comparing 150 RPM and 25RPM the overall distortion was 3.8mm as shown in Table 3.

Figure 13. Overspeed / transient condition Upper diagram – Agmin AG0° (red), AG90° (blue), AG180° (green), AG270° (purple) in mm; Lower diagram - rotational speed (red) in rpm, magnetic flux (blue in T

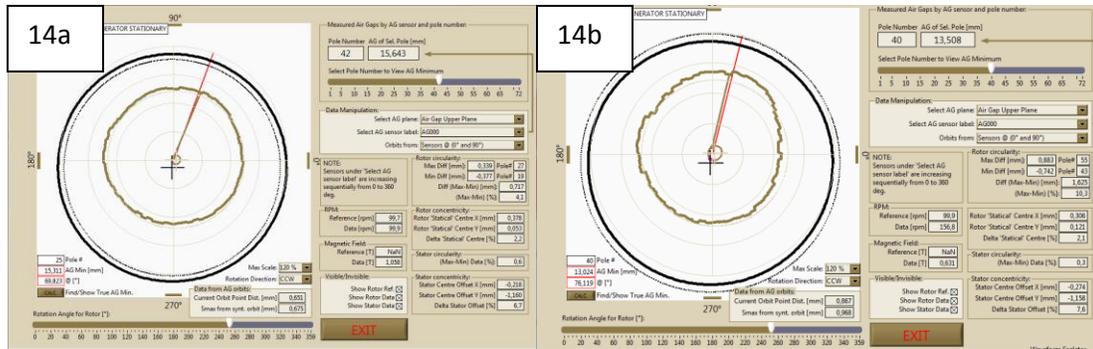
The shape at 157% RPM (Figure 14) shows that the rim became distorted at over speed in the section between poles 35 to 55. This is the result of the centrifugal forces overcoming the pre-load forces in the rim due to the rim shrinking after being heated for assembly.

Figure 14. Polar plot of stator and rotor geometry from all 4 sensors @ 90°, 14a 100% RPM, 14b 157% RPM

- 4.1% at 100 RPM
- 10.3% at 157 RPM
