THERMAL EXPANSION IMPACT ON VIBRO-DYNAMIC PROPERTIES OF BULB HYDROGENERATORS

SUMMARY

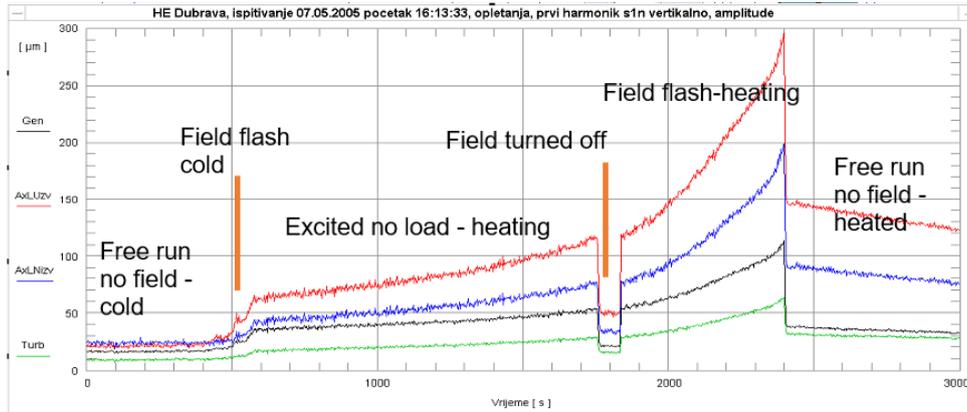
The first recorded event with high vibrations on Unit B was detected in May 2005 during the first run after a rotor replacement scheduled after 30 years in operation. The trend data of the shaft displacement amplitude at the machine rotating frequency, S_{1n} (first harmonic) are shown for vertical probes on turbine bearing, axial bearing downstream, axial bearing upstream and generator bearing in Figure 3. The system also has radial vibrations measured on the axial bearing, both radial bearings, and inside the air gap using the air gap probes and data analysis that enables accurate S_{1n} Amplitude and Phase calculation removed from air gap signal. This enables the plot of the dynamic shaft centerline from the turbine to the generator. This generator has a 6mm air gap, which is relatively small for a hydrogenerator. Therefore, the generator is very sensitive to magnetic unbalance. This first recorded event shows the following:

The heating process influenced the vibration response and in combination with the magnetic field the vibration amplitudes increased. In addition, at speed no-load after the heating process, the vibration amplitudes were much higher comparing than when the machine was in the cold condition, 150 μm peak compared to 60 μm peak on the axial bearing. The amplitudes reduced as the machine cooled down spinning at speed no-load. The conclusion was that thermal bowing (thermal rotor line deformation) was

causing the unbalance, both mechanical and electrical. After re-aligning the machine and additional balancing the machine was commissioned successfully.

Figure 3 – vibration amplitudes in vertical direction on first harmonic, S1n in vertical direction (dir 2), recorded in first run after rotor replacement on Unit B in May 2005 / Red= Thrust bearing upstream; Blue= Thrust bearing downstream, Black= Generator, Green= Turbine

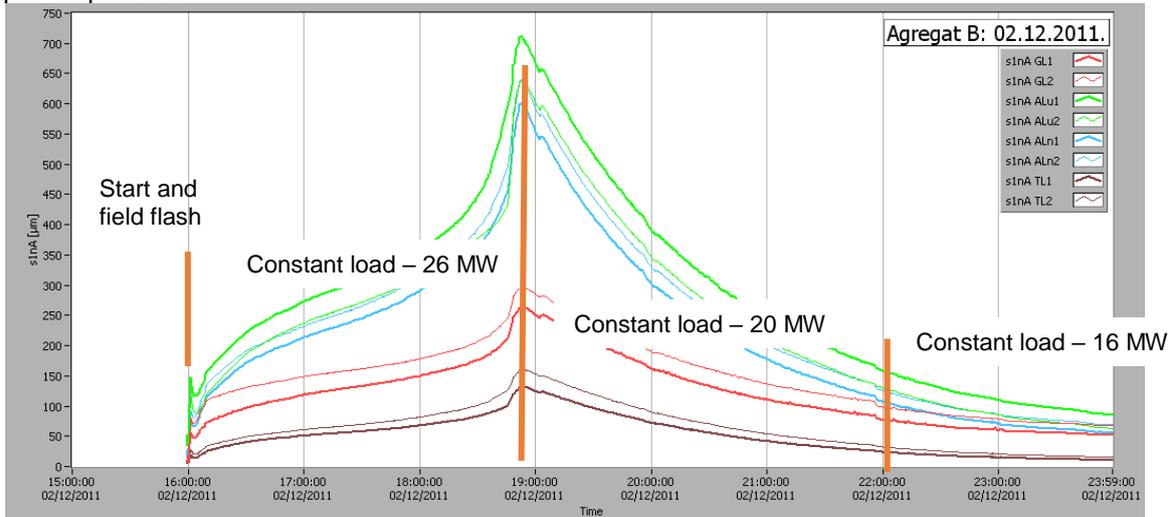
Figure 4 shows a similar such event recorded by the monitoring system after a regular start up in December 2011. The graph shows S1n amplitudes on all bearings. Shaft displacement on the Axial bearing (no radial clearance) increased up to 720 µm peak. The machine operating conditions were constant (both active and reactive power) during whole period. During an overhaul in January 2012 cracks were found in the shaft-to-rotor rim, likely related to this event, leading to longer downtime during this overhaul. Overhaul on bulb units include dewatering and taking the rotor out is quite complicated, so overhauls take long and are quite expensive.

Figure 4 First harmonic of shaft displacement during Unit B machine operation in December 2011

The cracks were fixed, rotor centered, and the machine was put back in operation with no root cause identified. After this event, a similar instability was detected by the monitoring system shown in Figure 5 with lower displacement amplitudes than in Figure 4. The shaft displacement on the Axial bearing upstream and downstream (ALU and ALN) started to rise while the machine was operating in steady state conditions. The vibration amplitude increase was constant even when the load was reduced, and the stator temperatures started to decrease. The rate of change was not linear and lowering the load had no effect on the amplitude rise. After this event, during steady state operation the vibration amplitudes reduced to normal condition at 50 µm peak. The first diagram in Figure 5 shows the axial bearing shaft displacement, the second shows the Active power and stator winding temperatures, the third diagram shows the S1n amplitudes of the rotor displacement inside the air gap, obtained from the air gap probes around the stator

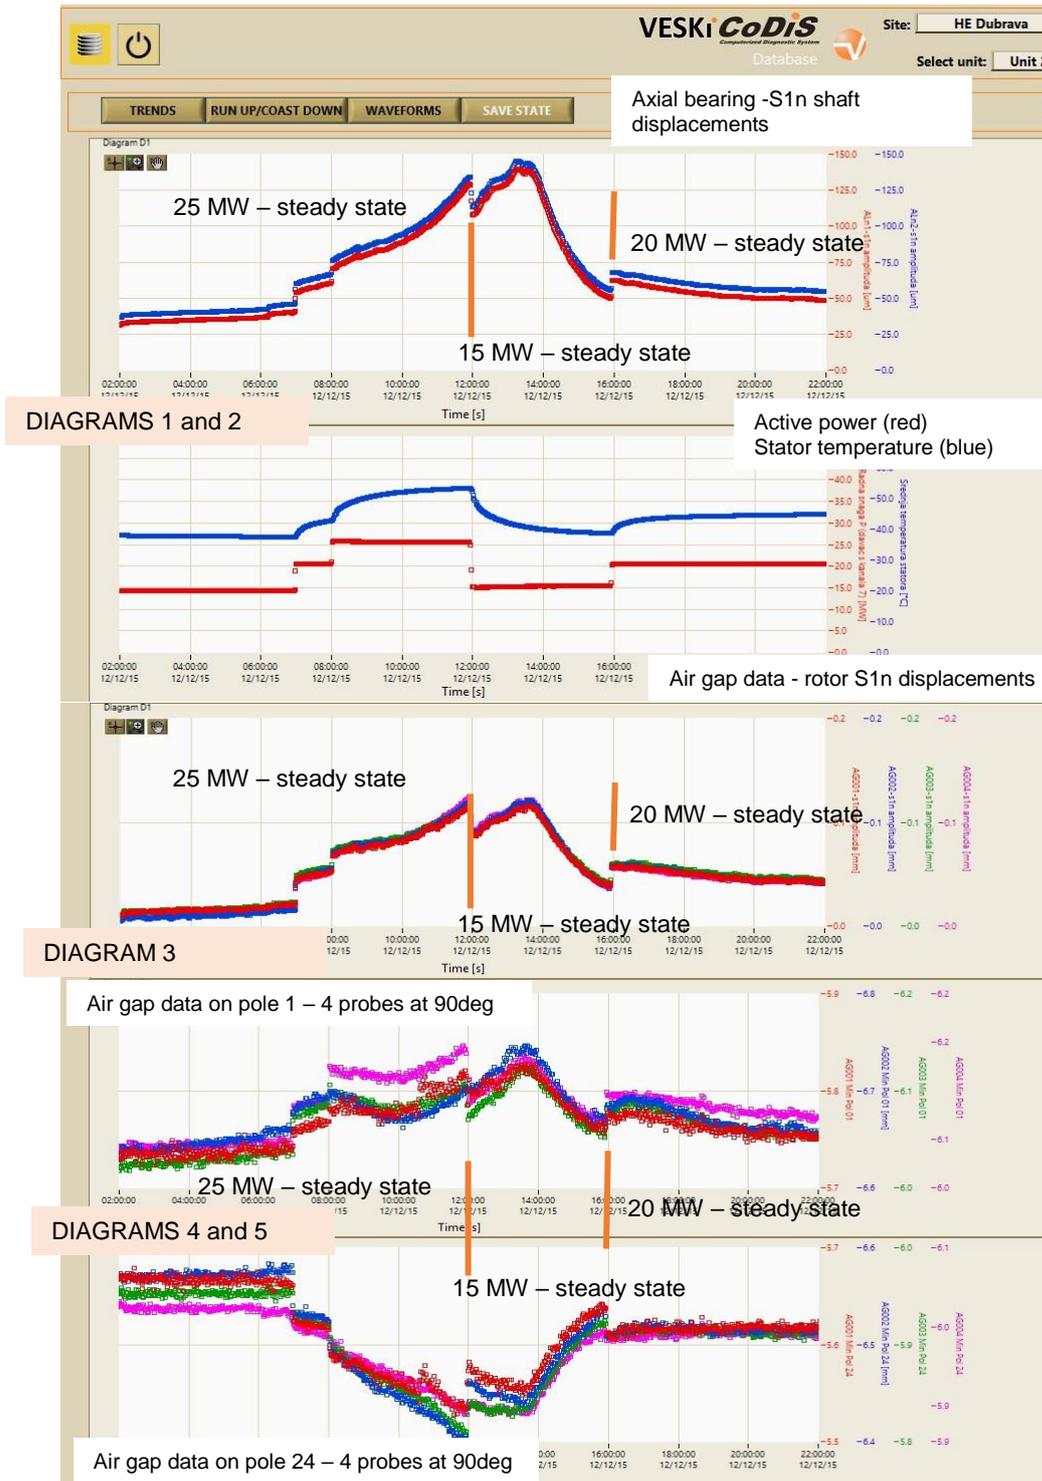
circumference at 90°. The rotor displacements corresponded well with the axial bearing displacements. Any thermal bowing should be visible in the air gap data with consistent results at different poles.

The fourth diagram shows the minimum air gap trend on pole 1 and the fifth on pole 24. The monitoring system records the pole profile data for each probe which will have 48 minimums for each data set since there are 48 salient poles in this machine. The trends in diagrams 4 and 5 represent the air gap value for each probe at pole 1 and 24 because they display opposite results. For this event, the deflection was largest in direction from pole 1 to 24 since the minimum air gap value was smallest at pole 24 at the same time it was the largest at pole 1 indicating the rotor was closer to pole 24 during this event. It should be noted that for some of the other events the thermal bowing was in different directions. This data indicates that the shaft was bowing during these events, but the cause of the bowing is still unknown.

Figure 5 – trend diagrams for several cross-correlated values on Unit B

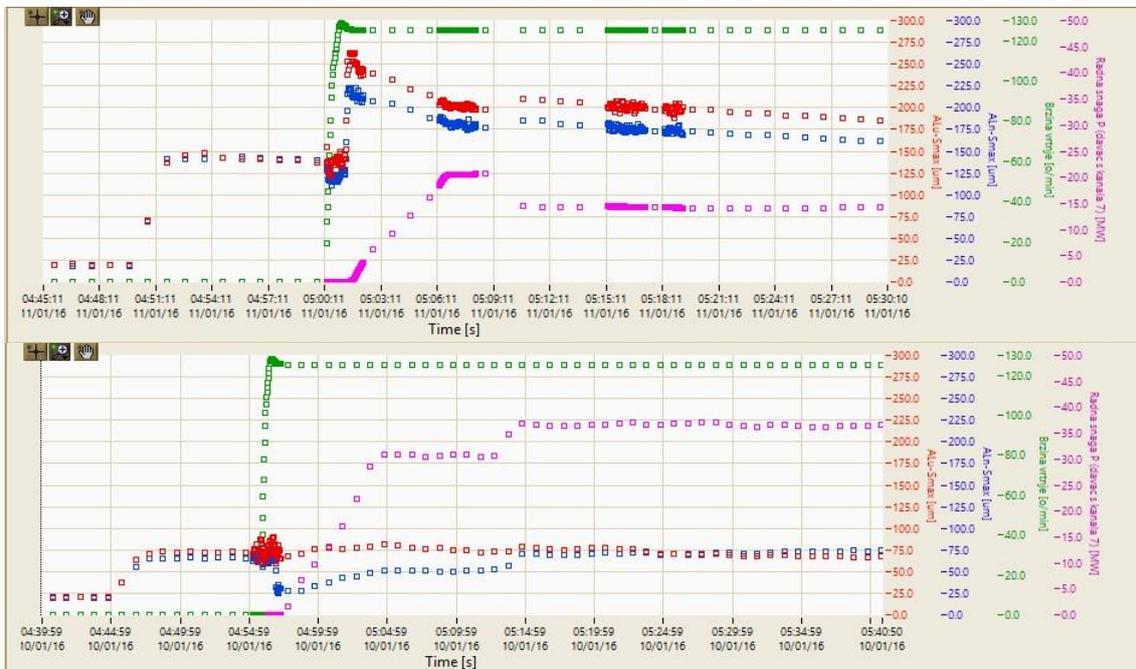
Figure 6 shows the trend data for S_{max} on the Axial bearing upstream (ALU – red curve) and downstream (ALN-blue curve), Active power (green curve) and shaft Speed (Magenta curve) during two start up events on 10.01 and 11.01. 2016. The upper diagram represents the start-up on 11.01. The machine was turning in slow roll for 15 min before it went up to full speed and was connected to the power system and loaded. During slow roll, the monitoring system recorded high amplitude S_{max} on the axial bearing at approximately 120 μm that increased to 270 μm when the machine started to speed up. During the start-up on 10.01 shown on the lower diagram, the S_{max} during slow roll was much lower in comparison and there were no significant vibration amplitudes present when the machine sped up. This indicates that when thermal bowing is present during slow roll, the field flashing causes magnetic unbalance resulting in high vibrations during start-up. If the thermal bow is not present, then the vibration amplitudes remain low while the machine is speeding up.

Figure 6 – Vibration response during two start up events recorded automatically by monitoring system

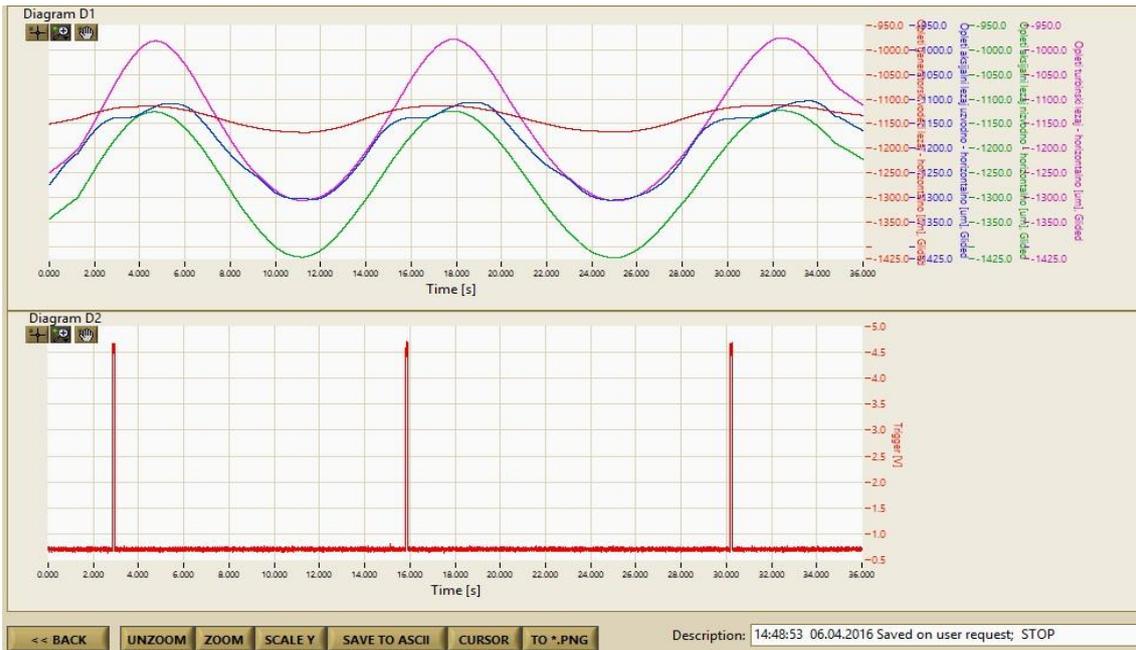
The slow roll shaft displacement was detected several times by the monitoring system automatically when the shaft vibration amplitudes triggered an alarm while the machine was speeding up. During alarm events the software captured raw data from all the probes for 36 seconds for post processing. One such event is shown in Figure 7, which represents the raw data from horizontal probes on all four bearings (TL – turbine / magenta curve, ALU – axial bearing upstream / blue curve, ALN – axial bearing downstream / green curve, GL – generator bearing / red curve). On the lower diagram is a shaft trigger – showing 1 turn in 14 sec ~4RPM. Even though machine had no dynamic forces present for such a low speed, it is visible that shaft displacements were relatively high. This indicates the shaft Run Out measured at slow roll was caused by thermal bowing. This bowing was not always the same since shaft geometry irregularities such as centerline Run Out would not always be present.

Figure 7 – Raw data recorded during slow roll, before machine start up.

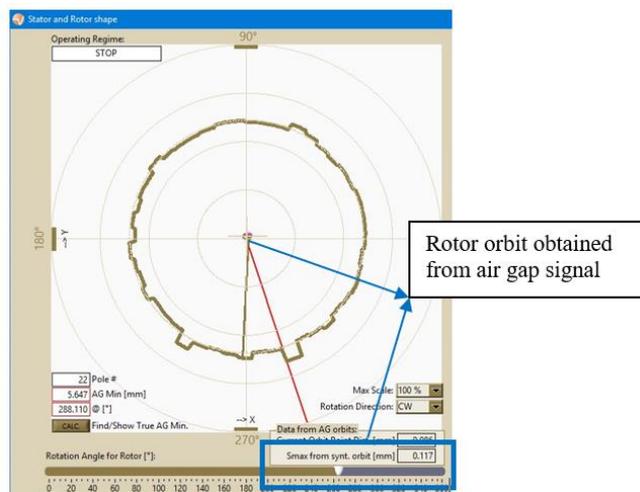
To support this, air gap vibrations were observed during the same slow roll event as shown in Figure 8. The monitoring system treated this as a STOP condition, since the machine was turning at only 4 RPM. The polar rotor shape consists of the rotor pole distribution inside the air gap, recorded by each probe, with the rotor dynamic eccentricity extracted. The dynamic eccentricity is shown as the rotor center orbit on the first harmonic of rotational frequency, S_{1n} , on the same plot as a center of the rotor. The rotor dynamic eccentricity maximum displacement, S_{max} was 117 μm . That number was calculated from two perpendicular air gap probes in the same manner as the orbit and S_{max} were calculated from proximity probes. The peak-to-peak movement measured from the air gap would be equivalent to 190 μm , while machine was turning at only 4 RPM, and no significant dynamic forces were applied to it. This is consistent with the data measured by proximity probes and in line with the bowing shaft theory.

Figure 8 - Air gap polar plot at 4RPM consisting of air gap rotor pole/rim geometry and eccentricity

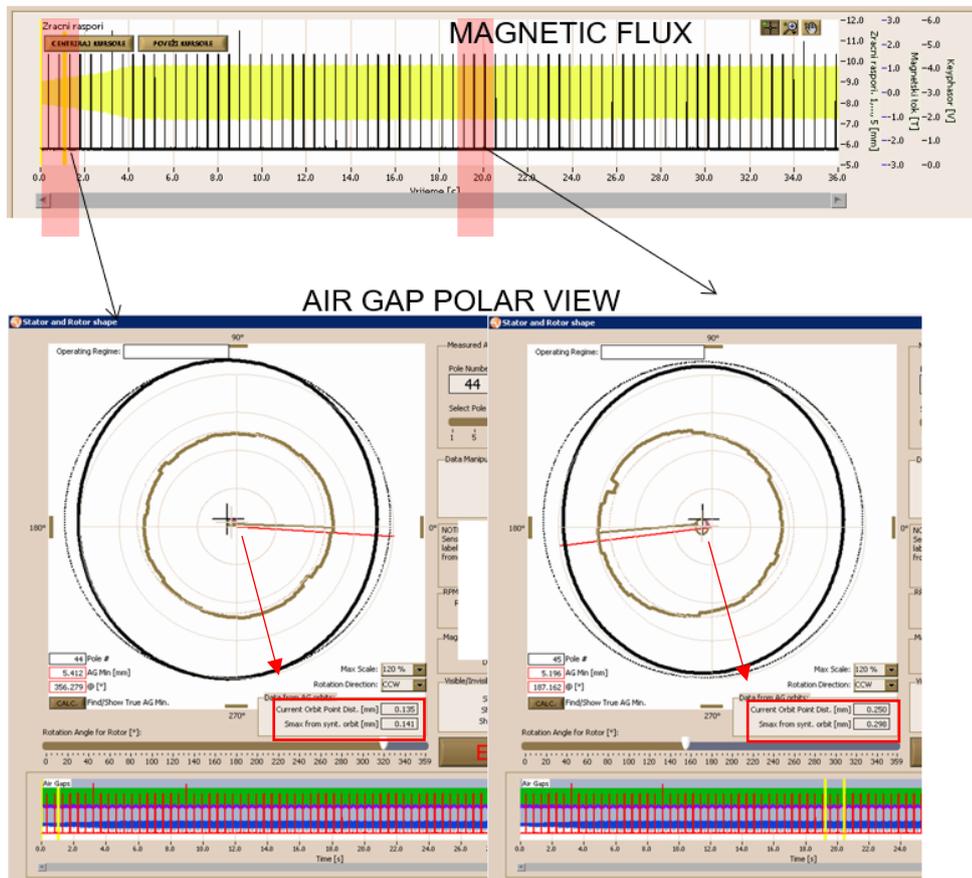
To further support that the cause of high vibrations during field flash was related to the shaft bowing, a comparison between the data before and after field flash was conducted during one run up and synchronization event recorded by the monitoring system, shown in Figure 9. The upper diagram represents the raw data of the Magnetic Field and the trigger signal. The lower two diagrams represent two events in time with a clear indication of the Magnetic Field impact on generator vibrations. The orbit plot inside the air gap indicates dynamic instability caused by the magnetic field, because the rotor bowing was present before the field flash event.

This is also visible as an orbit inside the air gap. In the cases where there was no bowing present on this machine, there was no sudden increase in vibrations with field flash.

Figure 9 – Comparison between field flash and minimum field during start up and synchronization event

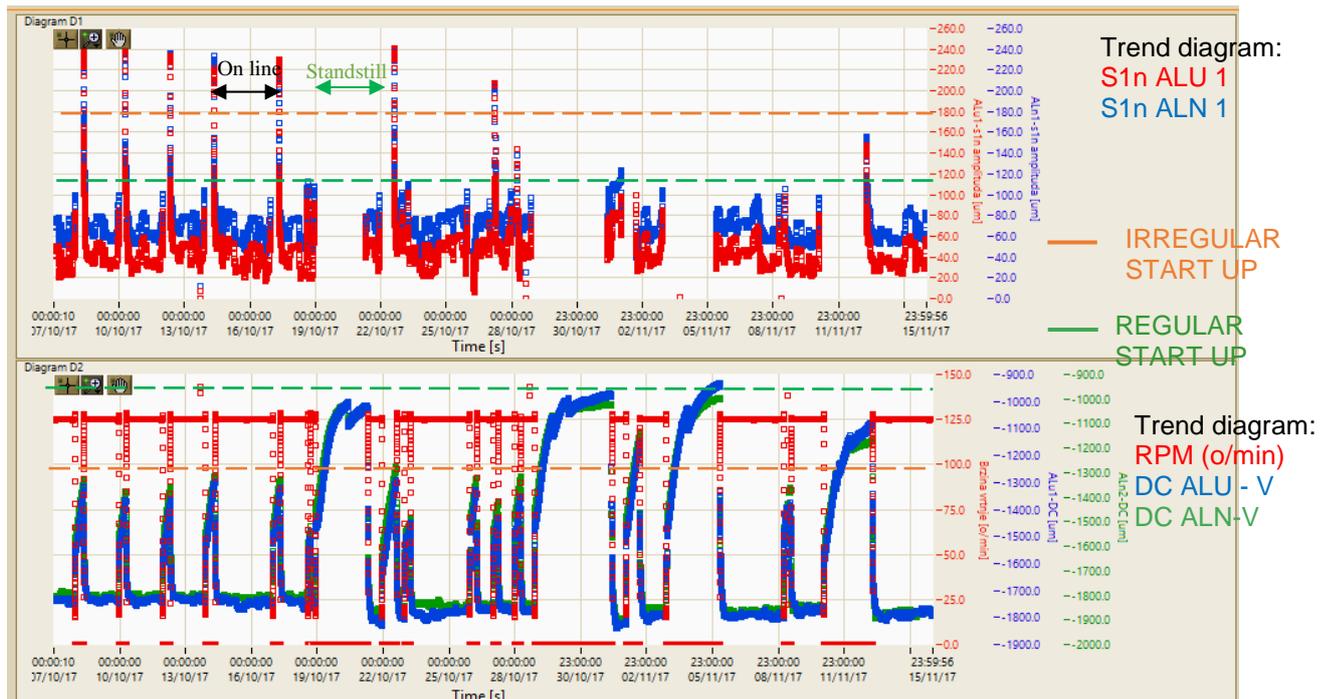
In order to determine the root cause of the high vibrations due to thermal bowing multiple starts and stops were observed in an attempt to find a pattern. The upper diagram of Figure 10 shows shaft displacement, S1n on Axial bearing in vertical direction, both upstream on ALU (red curve) and downstream on ALN (blue curve) of Unit A. Both units show similar behavior, Unit A was chosen because of the clear distinction between standstill and running events which helps in understanding the mechanism of the described problem. The lower diagram shows machine speed (red curve), shaft static centerline, vertical direction on ALU (blue curve) and horizontal direction on ALU (green curve).

The largest changes of shaft static position was in the vertical direction during 48 hrs of stand still where the vertical shaft center position changed by 0.9 mm (900 μm) compared to only 0.25 mm (250 μm – not shown on this diagram) in the horizontal direction. The vertical sensor was above the shaft so the signal decreased as the rotor shaft lifted. This shows that during machine heating and cooling process there was significant change in the rotor line sagging in the vertical direction.

Figure 10 also shows the correlation between the shaft DC position signal and the high vibrations. The orange dashed line represents the threshold where this shaft DC signal had not reached the final levels, and the machine was experiencing high vibrations. The green dashed line represents those conditions where the shaft DC reached final levels and the machine did not experience high vibrations.

Figure 10 – Trend diagrams of multiple start and stop conditions on Unit A

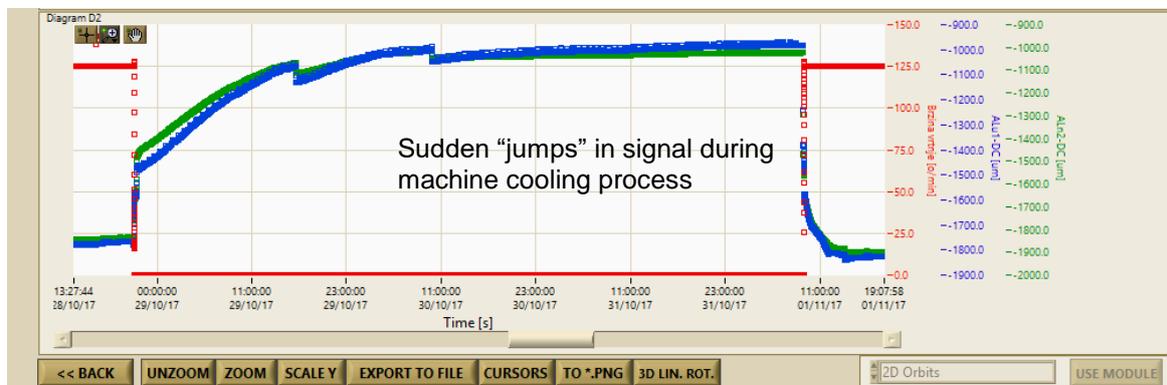
The Shaft DC signal (lower diagram of Figure 10) shows sudden amplitude fluctuation during this process. It seems that suddenly a force was applied on the shaft center and it repositioned itself. However, the cooling process continued and so did the shaft centerline movement upward to the sensor as the thermal bow straightened. It is clearly visible in Figure 11 during one of the longer standstill conditions from Figure 10.

Figure 11 – Shaft DC position during stand still condition, on ALN – vertical direction

This indicates a resistance to reverse thermal dilatations during the cooling process as if something on the rotor resisted the shrinking process as the temperature decreased. During the “regular” startup condition 19/10/17) the static shaft DC amplitude showed that the shaft was approximately 250 μm closer to the probe when compared to the previous start-up. Comparing the vibration amplitudes to S1n amplitude difference on ALU1 (red curve), between that two starts show a similar measured value (difference in S1n is approximately 200 μm). The conclusion is that the residual rotor line sagging was present as a thermal bow during those irregular startups. Similar behavior was present during other events.

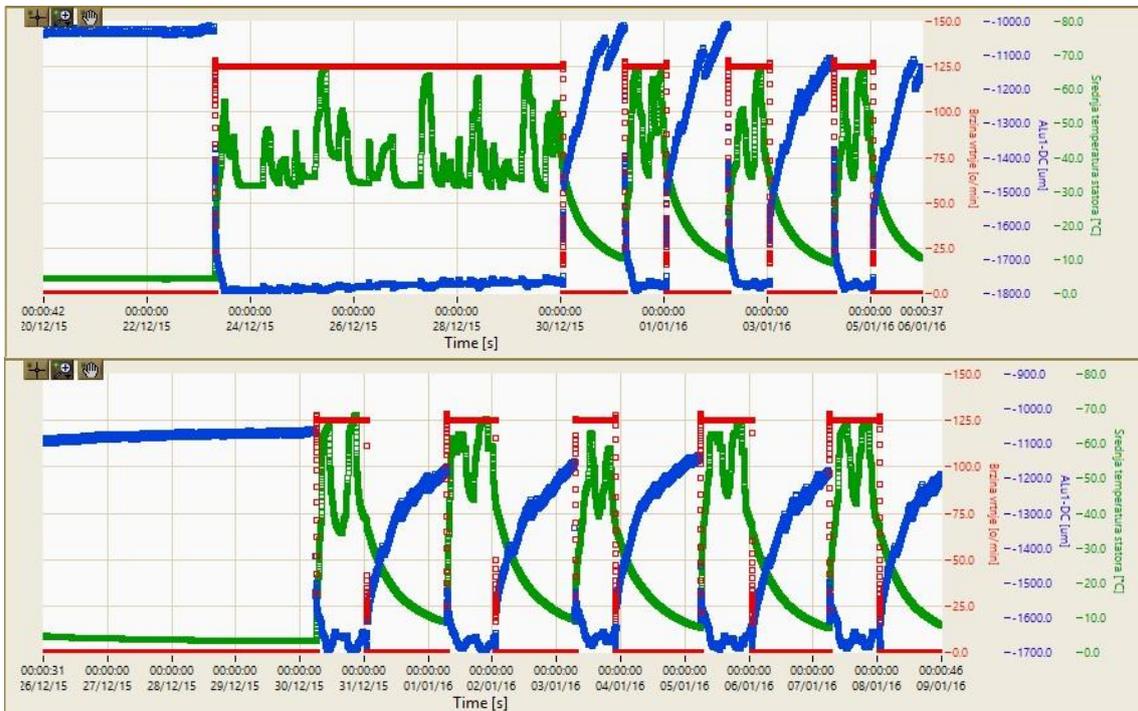
During operation at load, the rotor pole temperature was approximately 35-40°C higher than the rotor rim. Therefore, uneven rotor rim to pole heating and cooling could be one of the reasons for the bending forces to appear. This phenomenon is present on both units. The upper diagram in Figure 12 is for unit A and lower for Unit B of the same signals, Shaft DC position on ALU in the vertical direction (blue curve), shaft speed (red curve), and average stator temperature (green curve). Both time periods were selected when the starting point was taken after several days of standstill, during which the machine had a chance to completely cool down and stop re-positioning. Both machines had similar environmental conditions and cooling time should be similar to both machines for the selected time periods.

Figure 12 – Shaft DC position on Axial bearing and machine speed on Unit A (upper digaram) and Unit B (lower diagram) in same time period

The Shaft DC values can be used as a reference for comparison on each graph in Figure 12. Unit A shaft position reached a similar value in two stops, however not every time. Also, vibrations during those start-ups were low in amplitude, similar to the behavior shown on Figure 10. Unit B did not reach the same starting position even though the standstill lasted for 24 hours or more. As mentioned, both machines had the same environmental conditions (same time period, same water and air temperature) but they did not behave in similar manner. It can be concluded that the reason for this behavior lays in the different resistance to thermal deformations on both units. That resistance may be much higher on unit B, hence the larger amplitudes that resulted with the two mentioned events.

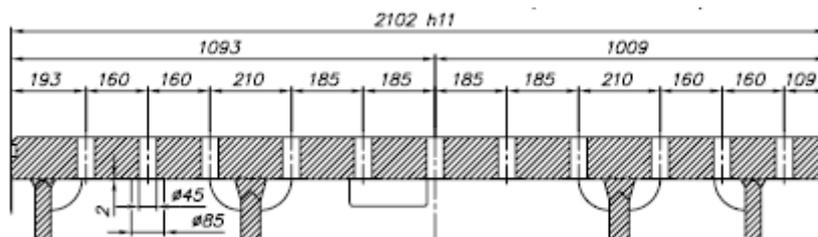
The cause of these deformations is still unknown. Considering the diagrams displayed and the machine design the conclusion is that the problem comes from the pole to rim attachment. The rotor rim cross section is shown on Figure 13. The poles on these machines are attached to the rim using 11 bolts. This type of attachment requires extreme caution during the tightening to ensure that poles are allowed to stretch and shrink adequately when heating and cooling.

Figure 13 -Rotor rim cross section

If all the poles do not stretch or shrink equally, due to friction or inadequate tightening, an uneven force distribution may occur around rotor circumference, resulting in the rotor shaft to bow. This conclusion must be verified, but the data and conclusions in this paper can be used by OEM as a baseline for further investigation and eliminating the root cause.
