CASE STUDY – 03

Hydrogenerator stator and rotor eccentricity

Problem: Detected large stator and rotor eccentricity

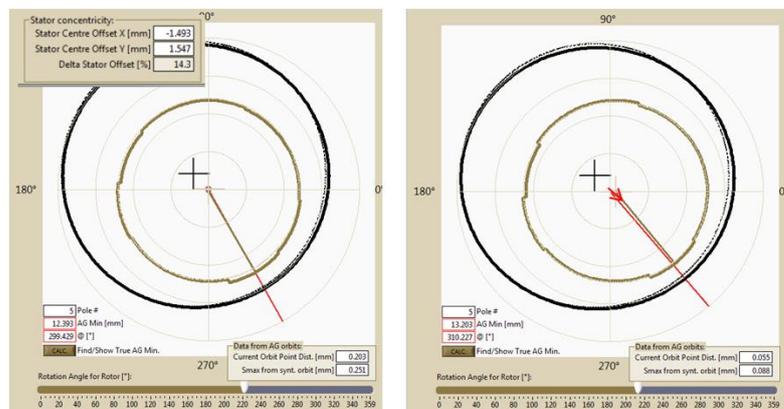
Before excitation

After excitation

Stator concentricity offset of 14% detected

The conclusion of the Veski experts was that vibration problems occur from the stator and rotor being eccentric which creates the static magnetic pull with field flashing. This was verified with CoDiS Air Gap monitoring module as shown on page 1. The pull is creating the load on that part of the bearing leaving the shaft no space to vibrate and making the oil film very stiff.

The plant personnel needed to conduct serious refurbishment that would include stator shifting to minimize the eccentricity and reduce the magnetic pull force.

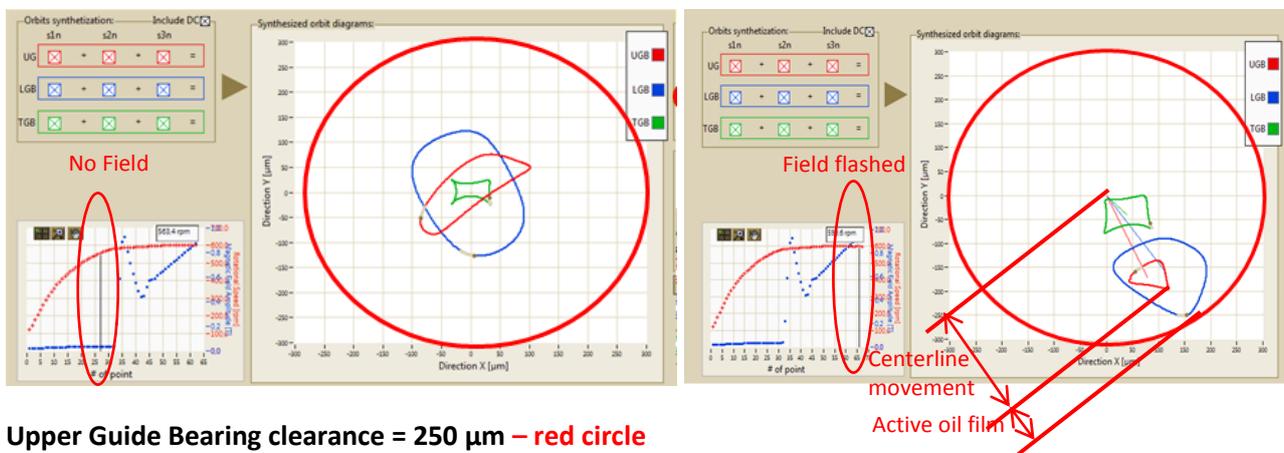
As seen from the plots below, the data is taken just before and after excitation on full speed at 600 RPM. Left diagram shows the position of the shaft at each bearing just before excitation and it is assumed that the rotor is spinning at the bearing's center. The right diagram shows the position of the shaft for each bearing after the excitation. The red circle represents the upper guide bearing clearance.

Orbit colours: upper guide bearing – red; lower guide bearing – blue; turbine guide bearing – green

Upper Guide Bearing clearance = 250 µm – red circle
Shaft centreline movement DC = 170 µm
Orbit Smax = 50 µm

This is also visible in absolute bearing vibration measurements which increase from 0.75 mm/s to 4 mm/s with field flash whereas relative shaft vibrations decrease due to lack of space to move inside the bearing.

This load on the bearing was the reason for the cracked seal and oil leakage that was occurring repeatedly over the years.
