Dynamical loads and the consequences in the Rough Load Zone Operation – case studies

SUMMARY

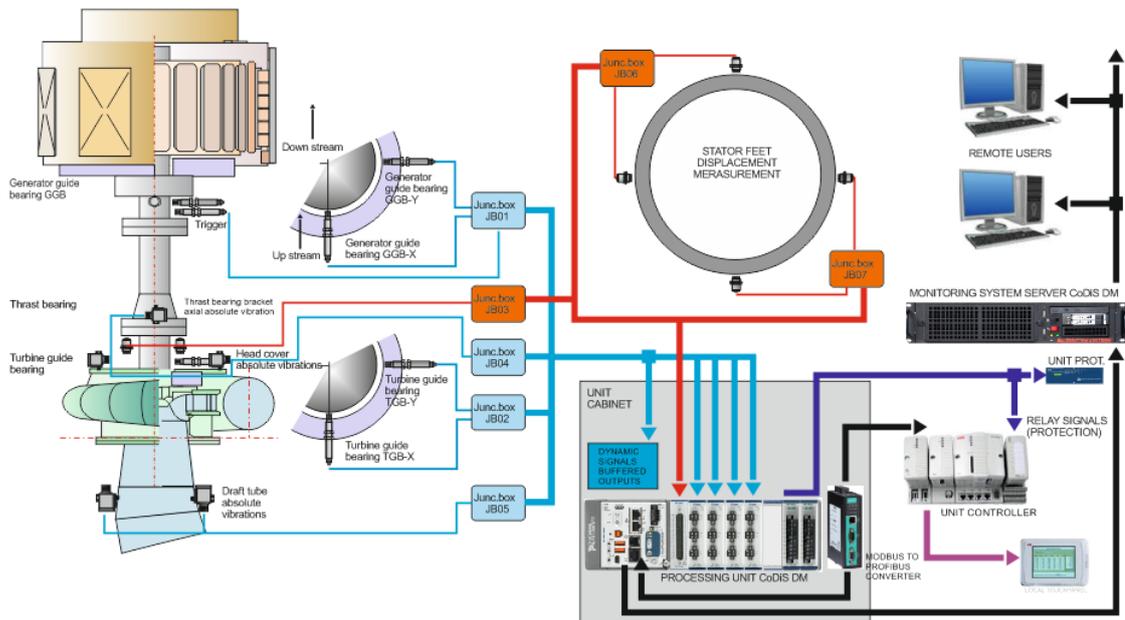
Machine condition monitoring systems were installed and commissioned on 4 machines with 120 MW rated power Francis turbines. They were umbrella type hydro generator designs with the axial bearing below the generator guide bearing and above the turbine guide bearing; GGB (generator guide bearing), TGB (turbine guide bearing). One machine with extended sensor configuration was selected to better understand the condition, behavior and consequently the root cause of the problem that these machines experienced during operation. The configuration of the system in Figure 1 included the following measurements:

- Machine speed (RPM)
- Relative shaft (radial) vibrations
- Absolute bearing (radial) vibrations
- Axial bearing vibrations
- Turbine cover vibrations in axial direction¹
- Axial rotor displacement²
- Stator feet to concrete foundations expansion (radial)³.
- Radial vibrations on draft tube

Figure 1 – Monitoring system layout.

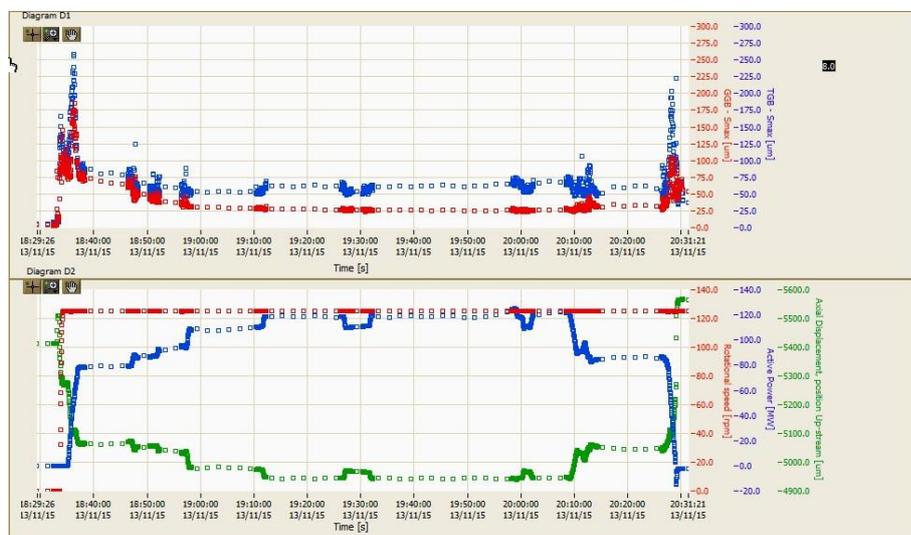
Figure 2 shows the Smax trend data in two radial bearing planes (GGB and TGB) alongside operating condition indicators recorded during same period. In the zone of 50 MW operation the vibration amplitudes were much higher than the amplitudes recorded during full power load. It appears that the machine passed through the RLZ twice 1) during load increase and 2) during the shut-down process. At 50MW, the TGB vibration amplitudes (Smax) reached a maximum at ~300 µm

Figure 2 - Upper diagram: Smax @ GGB & TGB; Lower diagram: RPM, Active Power (P) & Axial Displacement.

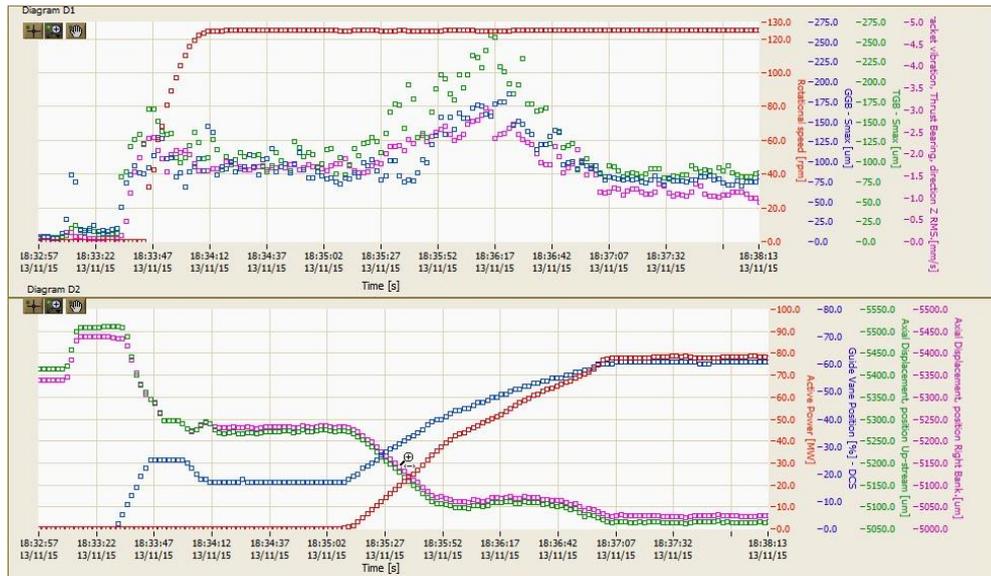
Further analysis required a more detailed observation in that particular power span. Figure 3 is zoomed in while the machine passes through RLZ during the load increase process. The parameters shown are:

Figure 3 – Upper diagram: *RPM*, *Smax* on *GGB* & *TGB*, *Vrms* on *ThrB* in axial dir; Lower diagram: *P*, *Guide vane opening*, axial displacement *US* (Upstream), and *RB* (Right Bank).

Since RLZ operation can lead to large vibration response in the axial direction it is important to analyze the behavior of axial displacement signals. The axial displacement sensors were located below the rotor so as the rotor moved away from the probe the signal increased. It was visible that during standstill the axial displacements increased by ~100 μm , which was likely an effect caused by the oil lift circulating in the axial bearing. As the machine started to rotate the axial displacement signals decreased as the water pushed down on the rotor. When the machine was in mechanical free run the axial displacement signals were stable.

The axial displacement signals started decreasing with load as more water increased the force acting downwards on the rotor. This was visible during 0 to 40 MW load operation, but more significant results were after 40MW during RLZ operation when the axial displacement increased and achieved a stationary state until the machine reached 60 MW load. After that the axial displacement decreased again as expected, achieving a constant value at a steady load of 80 MW. At the same time, the *Smax* vibration levels on the *TGB* increased from ~80 to 100 μm before the RLZ to over 250 μm at ~50 MW during the RLZ occurrence. Similar behavior with smaller amplitudes were recorded on the *GGB*. Absolute vibrations *Vrms* signal (axial) on the thrust bearing increased up to ~3 mm/s RMS at ~50 MW and then decreased to 0.5 mm/s RMS with load increase.

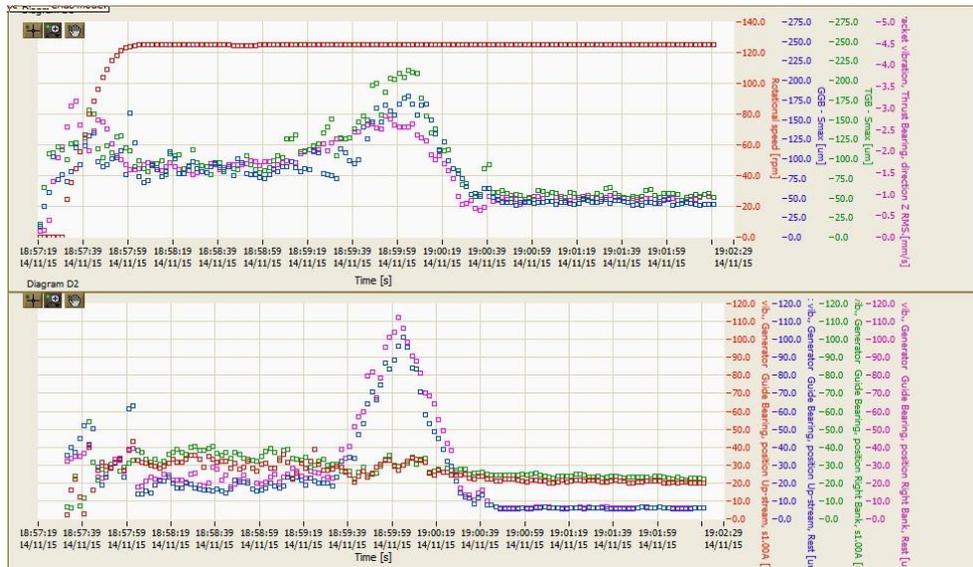
Figure 4 shows vibration *Smax*, *S1n*, and Rest comparisons with the intention of focusing on specific frequency ranges for further data analysis. *S1n* vibrations did not experience any changes during RLZ, whereas the Rest signal components completely follow the *Smax* behavior and increased during RLZ operation.

Figure 4 – Upper diagram: RPM, Smax on GGB i TGB, Vrms on ThrB in axial dir; Lower diagram: s1.00A on GGB US and RB, and Rest on GGB US and RB.

It should be noted that similar response was present on the Turbine Cover axial vibration but are not presented since Figures 4 and 5 sufficiently describe the machine behavior. It can be concluded that during RLZ operation high vibration amplitudes occurred at specific frequencies not related to the machine rotation. This event represents dynamic instability which requires further analysis in the frequency domain to completely understand the machine behavior, the impact of this instability to the machine, and whether this poses any danger to the reliability of the machine.

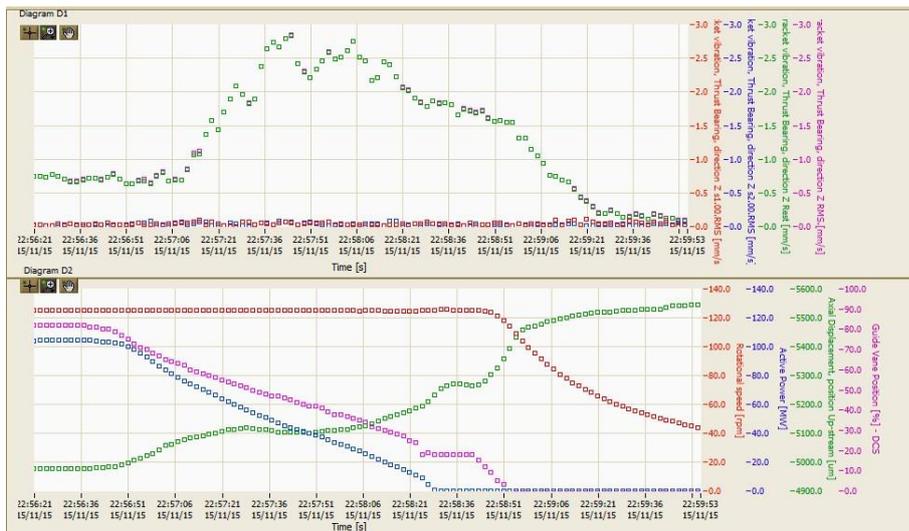
Similar behavior can be identified in Figure 5 where the axial vibrations S1n, S2n, Rest, and overall RMS signal of vibration velocity show that the order related amplitudes did not experience any difference during RLZ whereas the Rest signal component increased in the axial bearing vibration.

Figure 5 – Upper diagram: Axial (ThrB) – s1.00A and s2.00A, Rest and RMS; Lower diagram: RPM, P, Ax displ US, Guide wane opening.

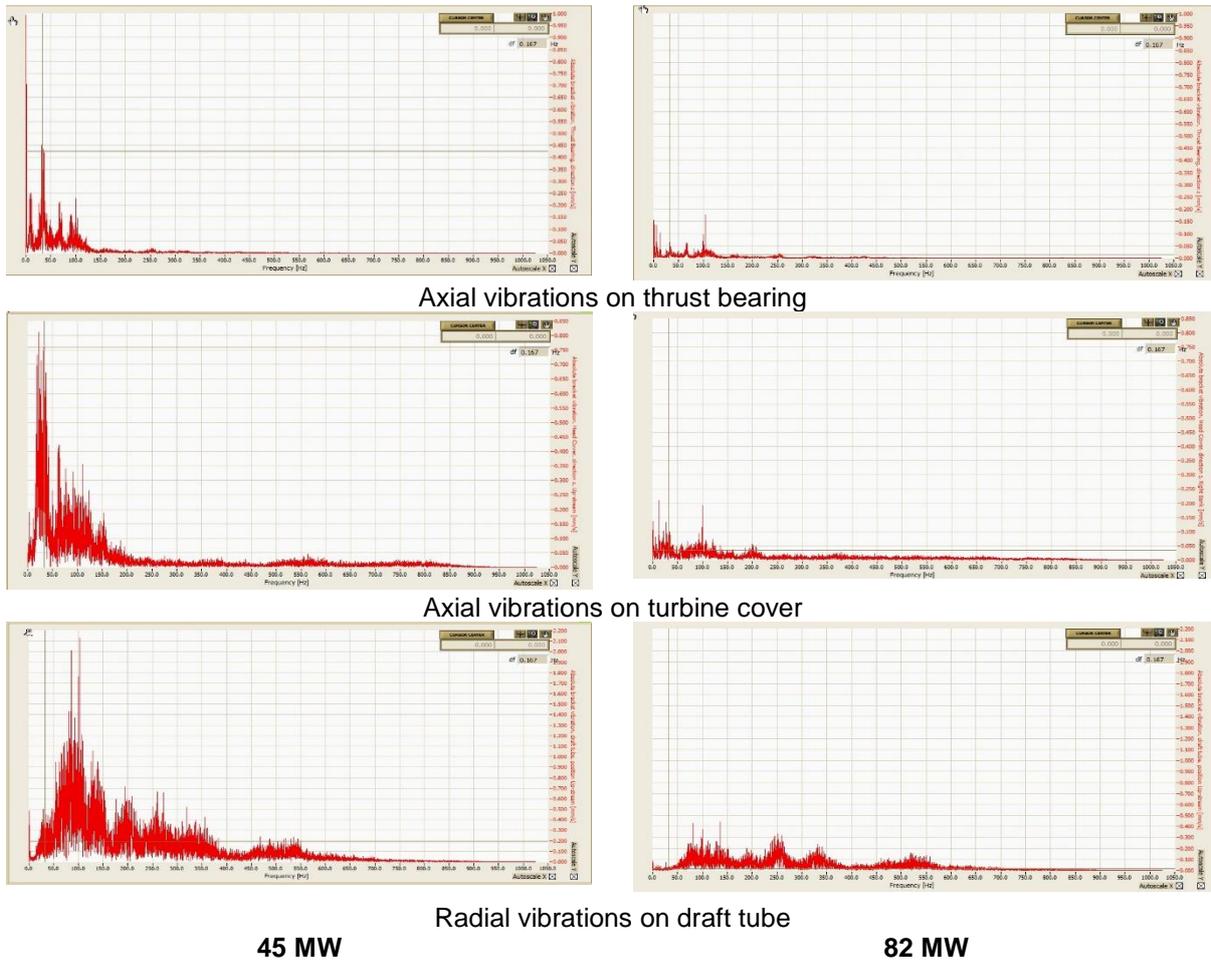
The monitoring system recorded both the condition vector⁸ signals (history trend) and raw data which was streamed in case of an event or additional analysis was required. This allowed for post processed analysis using tools such as FFT, as can be seen in Figure 6 with the vibration velocity spectrum

Figure 6 – FFT spectrum diagrams: LEFT SIDE: 45 MW, RIGHT SIDE: 82 MW.

Spectra were recorded during RLZ operation and during steady state operation.

At 45 MW (under RLZ):

- **Draft tube:** There were a lot of frequencies present, up to 600 Hz. This showed that overall RMS was high but evenly distributed mostly between 50 to 100 Hz. A peak at 0.5 Hz was present with lower amplitudes.
- **Turbine cover:** Dominant frequencies were up to ~150 Hz. A peak at 0.5 Hz was present with lower amplitudes.
- **Thrust bearing bracket:** Visible frequencies were up to ~120 Hz but was most dominant at ~0.5 Hz. Since no signal component was visible at other positions, it can be assumed that there was likely resonance in this area of the construction.

At 82 MW (outside RLZ):

- **Draft tube:** Spectrum up to 600 Hz with lower amplitudes at 45 MW which is somewhat typical for hydraulic measurements due to water flow impact on the structure.
- **Turbine cover:** Similar conclusion as for Draft tube
- **Thrust bearing bracket:** there was no 0.5 Hz component outside RLZ.

It can be concluded that on the turbine and draft tube higher vibrations were present due to hydraulic components and water turbulence which were at multiple frequencies as high as 600 Hz. On the Thrust Bearing there were low frequency components present that carry much higher energy and only appeared during RLZ occurrence. To determine the exact behavior more detailed analysis of lower frequencies was required.

All signals were driven by a 0.5 Hz component which is ¼X the rated rotational speed frequency. On the draft tube and turbine cover this frequency component had very low amplitudes (Figure 6) compared to the thrust bearing axial vibrations. The 0.5 Hz component in Figure 7 was not only visible in the axial direction but also in the radial direction of the relative shaft vibration signals. Also, shaft displacements on GGB and TGB were in counterphase which indicates minimal vibration between radial bearings. Rotor axial displacement signals do not show significant amplitudes at 0.5 Hz which means that the rotor was not moving relative to axial bearing bracket at those frequencies. Absolute thrust bearing bracket vibrations (and displacements shown as integrated signal on the right side of Figure 7) showed significant displacement levels at 0.5 Hz frequency. The overall displacement on thrust bearing bracket calculated from the integrated signal was:

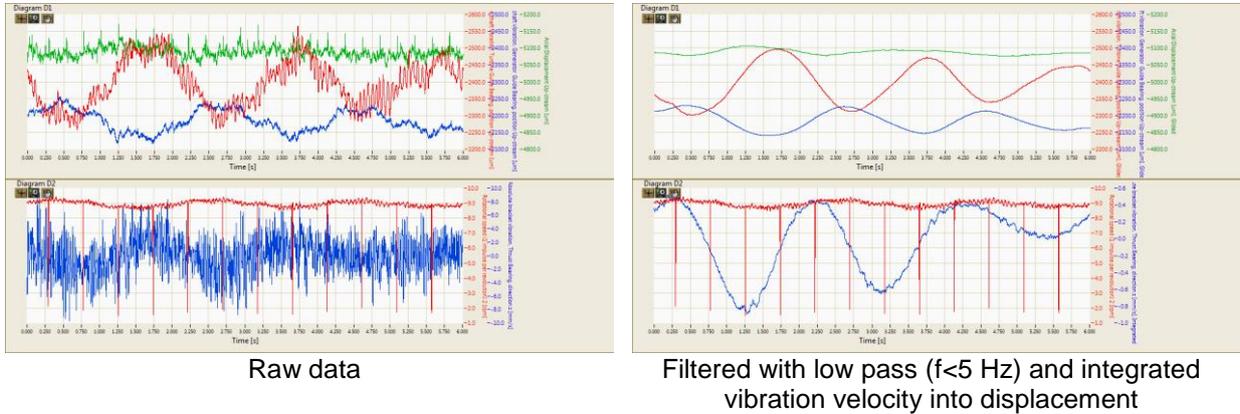
Figure 7 shows waveform signals on shaft vibrations at GGB and TGB in the Upstream direction and axial displacement alongside axial vibration velocity and key phasor. The left side shows raw data and vibration velocity (lower diagram, blue signal) and the right side shows a post processed signal through a low pass filter and integrated to displacement. This was recorded during 45 MW load operation.

Figure 7 – Raw data on 45 MW. Upper diagram (both left and right): Relative shaft vibrations on TGB – US, GGB – US, Axial displ. – US. Lower diagram: Key phasor i Vibration velocity (left) / Vibration displacement (right) on thrust bearing bracket

$$S_{axl} = 1.3 \text{ mm peak-to-peak}$$

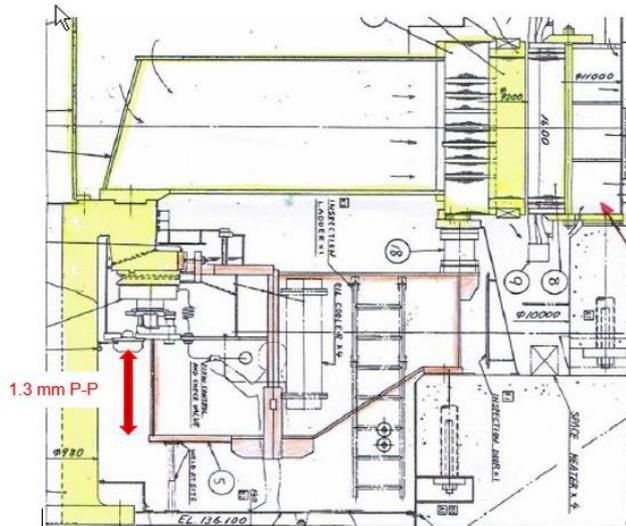
These values are excessive considering the rotor weight and hydraulic downward load was 875 T. The axial displacement of the rotor relative to the bracket was insignificant indicating that the complete rotor including the bearing bracket was vibrating together in the axial direction. Figure 8 shows the sensor position and displacement indication.

Figure 8 – Generator thrust bearing bracket and measurement point.

These displacement amplitudes generated a lot of stress in the bracket and could threaten the structural integrity. Measurements of axial displacement of the rotor to concrete foundations would be the

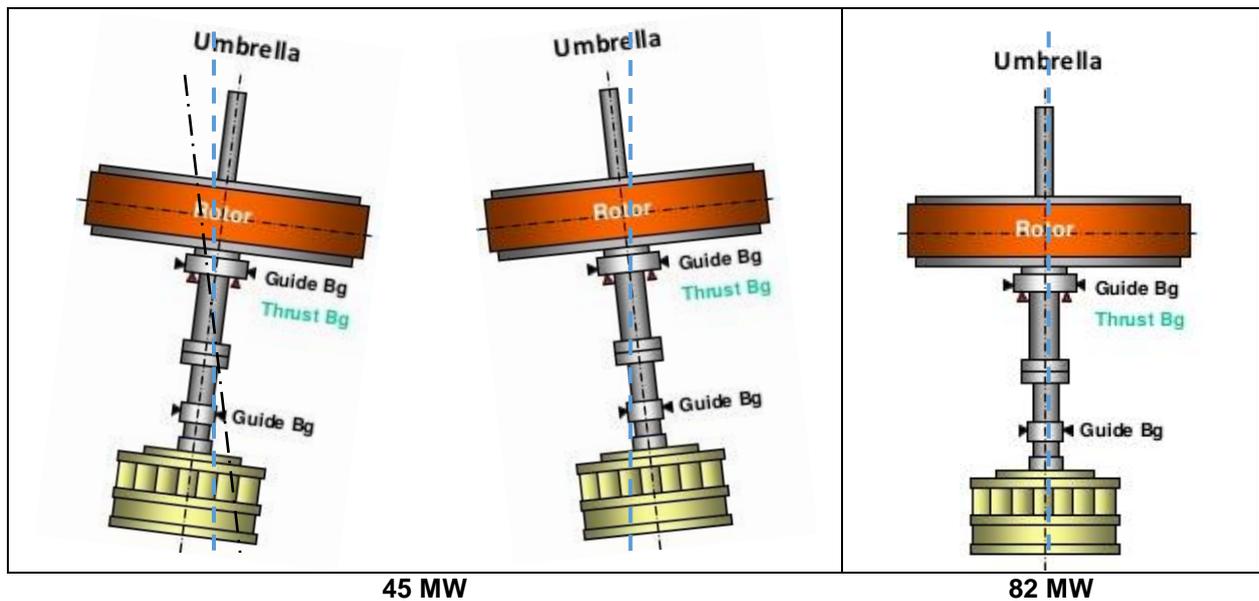
Analyzing the amplitudes and phases of the shaft vibrations indicate that the whole rotor had a precession movement around the rotor mass center as shown in Figure 9. The movement was mostly visible during RLZ occurrence at 45 MW load and practically not present at 82 MW load. To confirm this, an upgraded system with two more axial vibration sensors was recommended. This would allow the phase comparison at all positions and stiffness of the axial bracket to be determined from the response. If the stiffness decreased in any sensor it could be detected and quantified.

Figure 9 – Rotor precession movement at 0.5 Hz on various loads

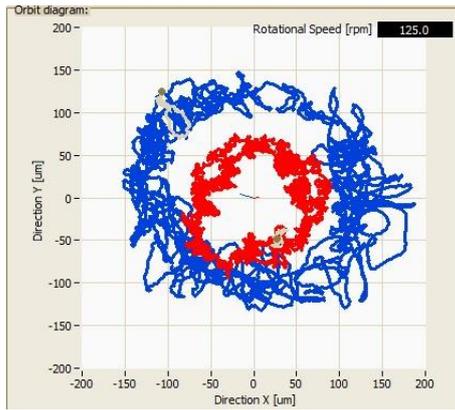
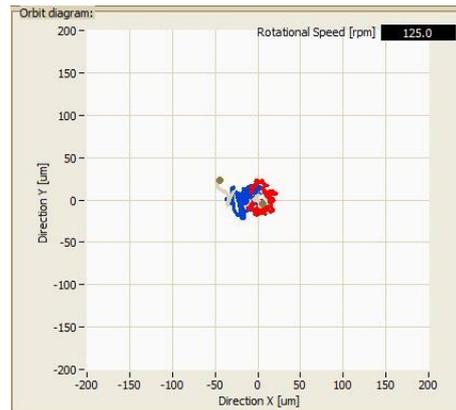
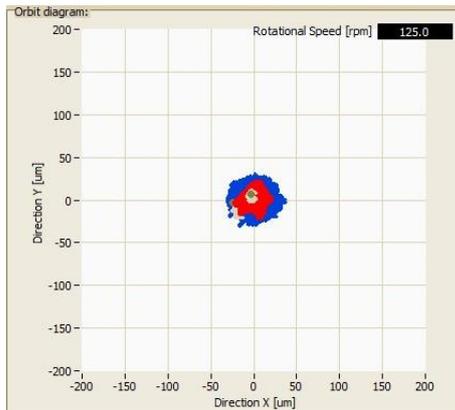
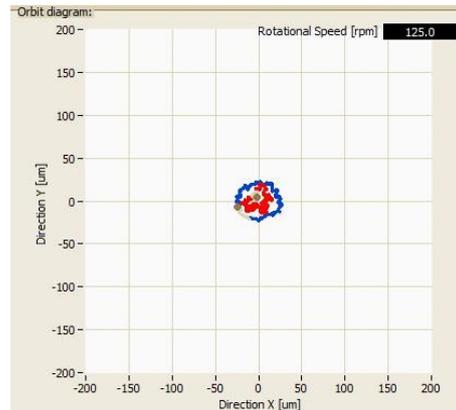
Analysis of the shaft orbits in Figure 10 supports the precession theory. Orbits display the X and Y signal plots from two perpendicular shaft displacement sensors in one bearing plane. Orbits represent the shaft displacement position (both dynamic and steady state) inside the bearing and represent directly the bearing clearance during dynamic operation of the machine. Therefore, they can be an important indicator of how much RLZ affects the bearings. In Figure 10 the orbits recorded during various load operations (50 and 82 MW load) are shown. On the left side, the complete signal duration is shown as X and Y plot from two probes (raw orbits). On the right side, are the orbits averaged per single machine revolution. It appears that low frequency components were affecting the shaft position significantly, but it is not visible from turn to turn. To display the real movement of both the wobbling frequency and the rotational speed simultaneously at least 4 rotations are needed since the wobbling frequency was $\frac{1}{4} \times$ the rotational speed. Comparing the left and right diagrams the low frequency component had significant impact during RLZ occurrence. When the machine operates outside the RLZ (at 82 MW) the wobbling disappeared, and the shaft orbits were at the frequency related to machine speed so both the raw orbit and the averaged orbit were practically the same.

Raw, 50 MW

Averaged per turn, 50 MW

Raw, 82 MW

Averaged per turn, 82 MW

Figure 10 – Orbit diagrams (raw and averaged per turn) on two load conditions (50 MW, and 82 MW), GGB and TGB

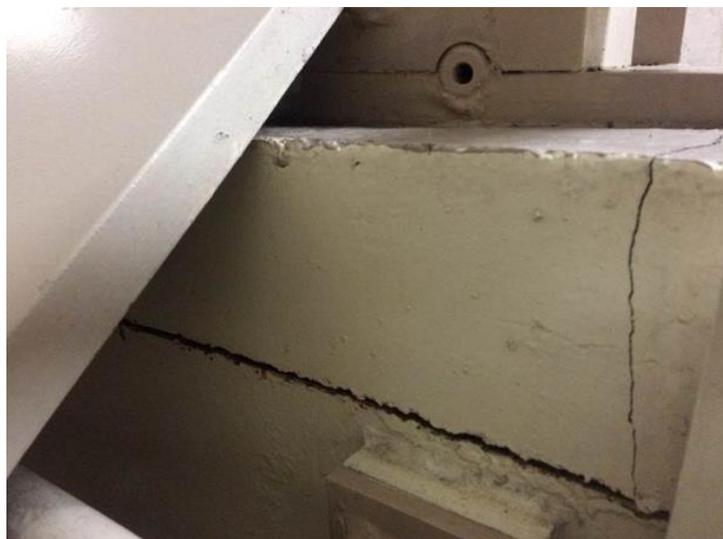
The wobbling was present due to the vortex generated under turbine runner, however the response in this case was mostly related to the machine design and the precession movement around the rotor mass which caused large displacements in the radial direction as a result of axial vibrations. The new standard published in 2018 for the measurement and evaluation of vibration in this type of machinery, ISO 20816-5 indicates that shaft orbits (peak-to-peak values of relative shaft vibrations) should not exceed 70% of the cold bearing clearance. In this case the shaft orbits were near this value meaning that there was a significant load on radial bearings in the RLZ. To support this conclusion, cracks have formed in the concrete foundations at the axial bearing thrust bracket supports shown in Figure 11 on another unit of the same design in this power plant that had experienced the same issues while operating in the RLZ.

Figure 11 – Cracks in bearing to foundation supports on other unit in the same plant

On the 120 MW machine case study the RLZ effect was posing a threat to the machine condition and reduced machine operability/availability. Cracks in the axial bracket to foundation support were found on a sister unit in the same plant. It was found that bracket deflections reached 2 mm peak-to-peak at 0.5 Hz. There was considerable stress in the thrust bracket which led to significant stiffness reduction and machine operability problems. Also, during RLZ occurrence the radial vibrations increased significantly, reaching values of bearing clearance limits as recommended by ISO 20816-5.

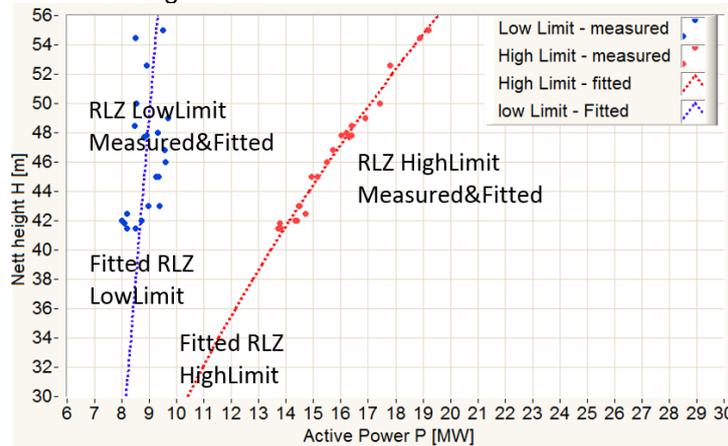
Data collection was carried out for over one year of operation and provided the possibility to correlate operating conditions with RLZ occurrence and map a machine availability chart dependent on water levels and power shown in Figure 12.

Figure 12 – RLZ mapping chart (Head vs Power)

The other case study showed that the RLZ was not fixed and very much dependent on upper and lower water levels (head). The power span in which one might expect the instability was changing according to water levels and so too the machine availability. For automated operations where the machines are driven by a dispatch center, this becomes very important information. Therefore, this paper presents the recommendation to map the RLZ for each machine and use that as a guideline for operating the machine remotely.

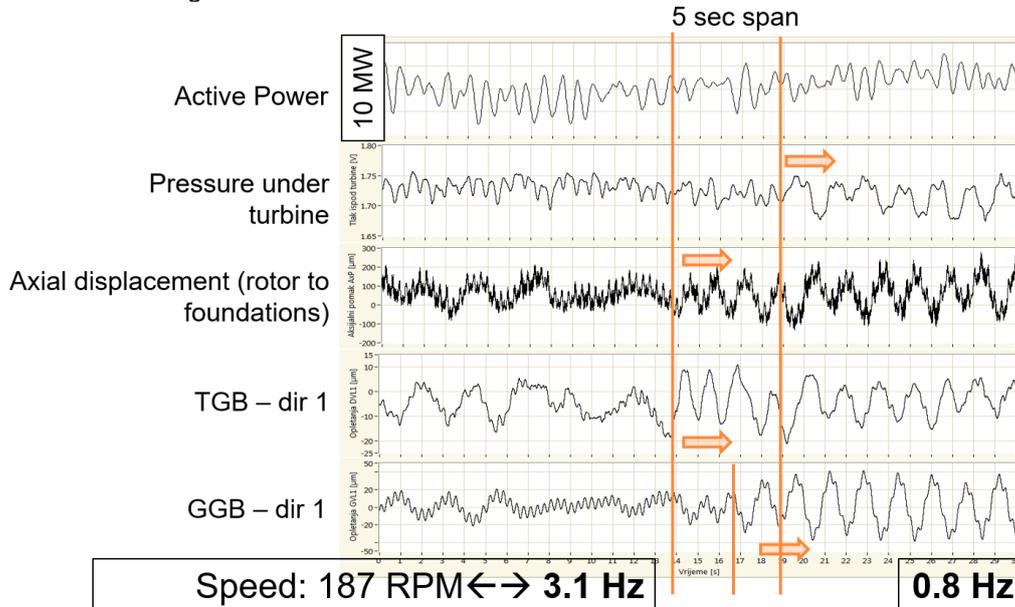
Another interesting result were the raw waveform data analysis during one of the RLZ events on this machine shown in Figure 13.

Figure 13 – Raw data recorded during RLZ operation on 10 MW

This 30 second data record represents the start of a vortex and the low frequency wobbling/pulsations at 0.8 Hz. Active power was 10 MW, showing approximately 1 MW fluctuations at 1.2 Hz throughout the complete data record. The most interesting result was the pressure pulsation signal

fluctuation. The pressure started to fluctuate at 0.8 Hz about 5 seconds after the rotor axial displacement and the shaft radial displacements on turbine bearing. The radial displacement on the generator bearing followed the axial and turbine displacement which started at the same time. Pressure pulsations at 0.8 Hz started 5 seconds later. These results were different than expected, as previous experience indicated that the pressure caused the rotor movement. It seems that these results show the opposite and that the axial rotor movement caused the pressure pulsations under turbine runner. Self-excited vibrations may be the cause of this phenomenon due to inadequate energy transformation on the turbine. In RLZ operation water flow on the turbine blades can lose its stability and the turbine does not effectively transfer the water kinetic energy to momentum. The left-over energy must be converted which triggers self-excited vibrations resulting in dynamic instability of machine.

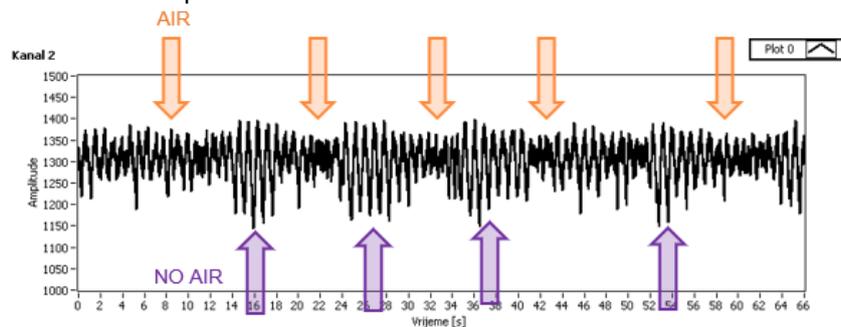
Since RLZ phenomena is related to turbine design and manufacturing there is little that can be done to remove it once present. It can however be mitigated with air admission under the turbine to eliminate the vortex and reduce the vibrations. Data was recorded during that experiment to observe the effect of the air admission on pulsations. Figure 14 shows the shaft displacement amplitude with air blown intermittently into the vortex to test the vortex elimination. The vibrations decreased during the air admission and increased when air was not present.

Figure 14 - Shaft displacement waveform at 8 MW - experimenting with air under turbine

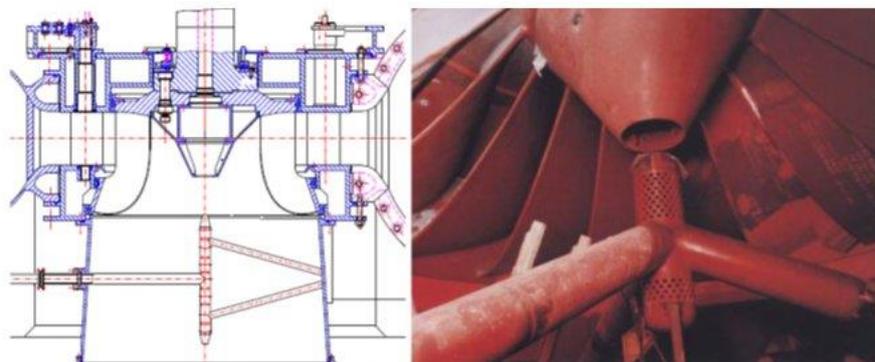
There are several available solutions to control the vortex such as fins in the draft tube to decrease the swirl and broaden the operating range, but these are often found to significantly reduce the efficiency. As well, modifications to the turbine cone including extension and/or grooves can be made which do not affect the efficiency as much but the pressure pulsations may cause large forces on the modified cone. The most common solution and the chosen option for this case was air admission directly under the turbine runner, as shown in Figure 15. Where the pressure under the turbine is higher than atmospheric pressure other methods such as “Jet Pump Turbine Air Admission” made by Fuji should be used to overcome the pressure differential.

Figure 15 - Air admission directly under the turbine

This paper also briefly considers several methods of reducing the effect of instability which are referenced below for a detailed description. Using the air admission under the turbine can collapse the vortex and effectively reduce the vibrations. Feedback between the monitoring system and the air admission system should be established for this system to work effectively.
