LARGE STATOR/ROTOR ECCENTRICITY - A UNIT FAILURE CASE STUDY

SUMMARY

Key words: Stator rotor eccentricity, Kaplan turbine, Unbalanced Magnetic Pull, Tangential key detachment

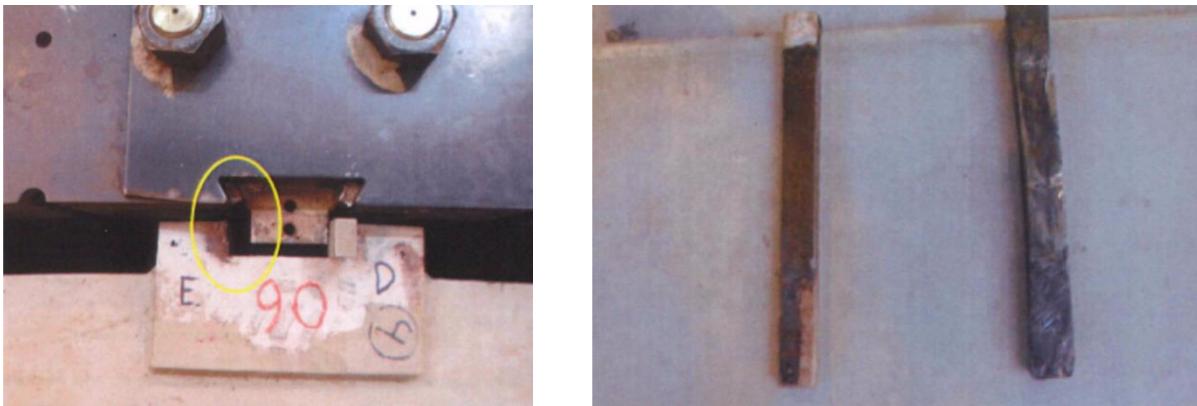
A 120 MW Kaplan unit failed in December 2015. The reason for the failure was the detachment of the tangential keys from the rotor causing damage to the stator core (Fig. 1). To find the root cause a detailed analysis of the data from the database of the installed monitoring system was performed.

Fig. 1 LEFT: Key that became loose in operation. RIGHT: Left key is the one found in the rotor hub, right key is the one that hit the stator core.

During the overhaul – the unit's eccentricity was corrected, also verticality and rim interference to spider (the rim is of a shrink fit type) of 2.1 mm. Keying procedure for guide keys was improved to provide better contact between the rim and the spider and transfer the torque adequately.

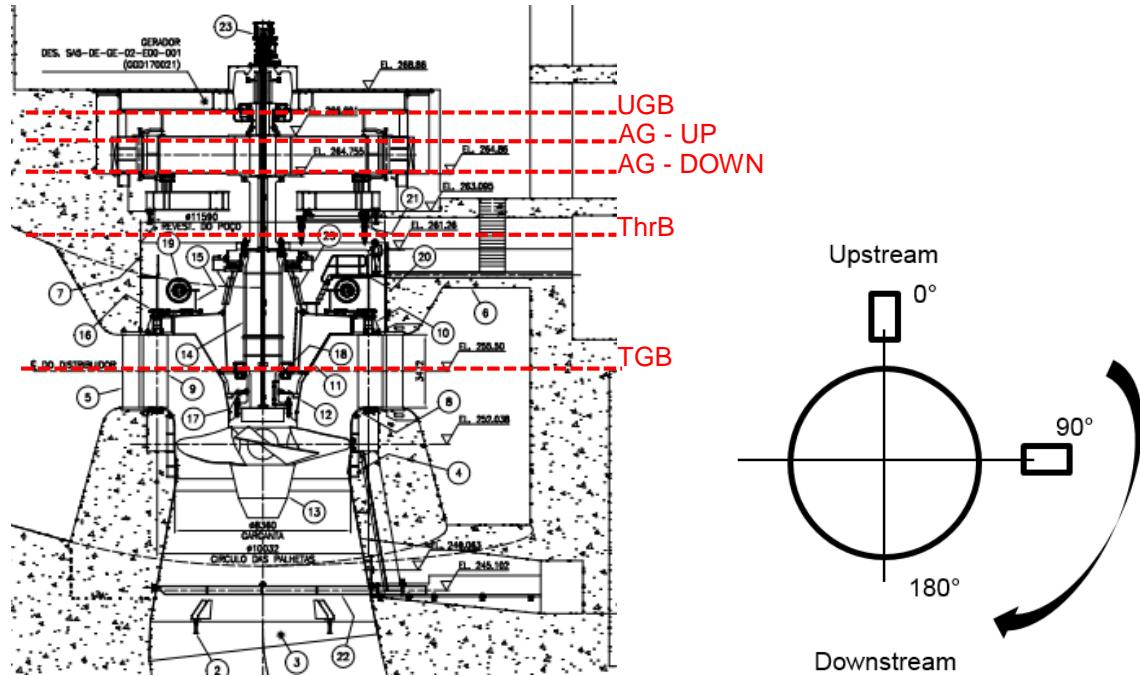
The machine is a semi-umbrella type with the thrust bracket below the generator and two guide bearings – one above the generator and the other at the turbine level. The unit's cross section with measurement planes and measurement directions is shown on Fig. 2.

Fig. 2 LEFT: Unit cross section with measurement planes indicated and noted. RIGHT: Sensor positions layout. Top view. Arrow indicates rotation direction (CW – clock-wise).

The planes and directions of measurement are indicated on Fig. 2. For relative vibrations – directions 0° and 90° were used.

Beside relative vibrations, useful informations were obtained using the **air gap sensors** installed in two planes – at the top and bottom of the stator core (AG – UP and AG – DOWN – as shown on Fig. 2). In total – there were 16 air gap sensors installed, 8 in the upper plane of the stator core and 8 in the lower plane of the stator core. The sensors in both planes were distributed at equal angles (0°, 45°, 90°, 135°, 180°, 225°, 270° and 315°) according to Fig. 2 (RIGHT).

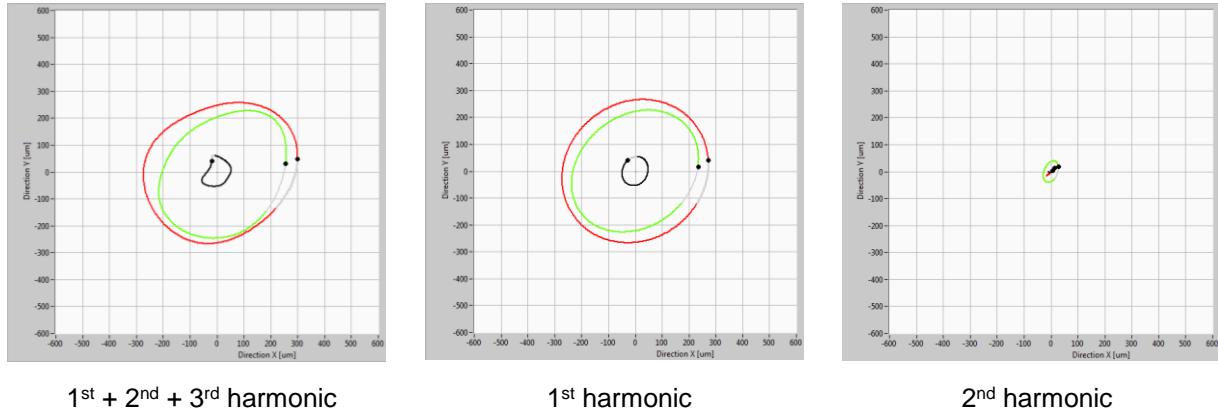
Fig. 3 shows the data before and Fig. 4 after the overhaul. Data is shown for the UGB, ThrB and TGB planes.

Fig. 3 Before the overhaul (July 2015): Orbit diagrams of relative vibrations in the UGB (black), ThrB (red) and TGB (green) planes in mechanical rotation (without excitation). At ~nominal rotational speed ~86.6 rpm. LEFT: synthesized from 1st + 2nd + 3rd harmonics; MIDDLE: synthesized from 1st harmonic; RIGHT: synthesized from 2nd harmonic of rotational speed.

In general, there was a **significant improvement in vibrational response in mechanical rotation after the overhaul**. Vibrations were reduced as can be seen by the size of the orbit. By dynamical two-plane balancing of the generator rotor – vibrational response could be reduced further. The first balancing plane for dynamical balancing should be UGB plane and the second one should be the ThrB plane. If vibrations on ThrB will be reduced – they will automatically be reduced on TGB.

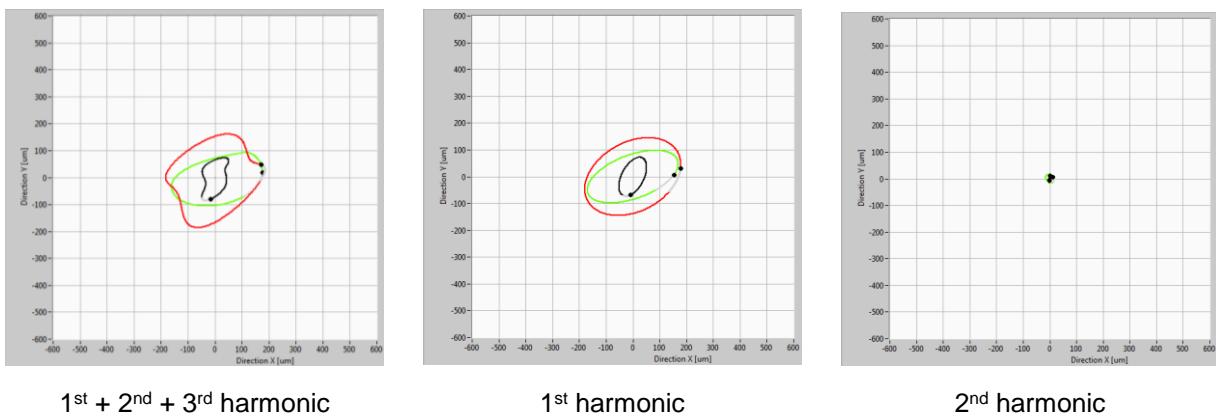
Fig. 4 After the overhaul (August 2016): Orbit diagrams of relative vibrations in the UGB (black), ThrB (red) and TGB (green) planes in mechanical rotation (without excitation). At ~85.7 rpm. LEFT: synthesized from 1st + 2nd + 3rd harmonics; MIDDLE: synthesized from 1st harmonic; RIGHT: synthesized from 2nd harmonic of rotational speed.

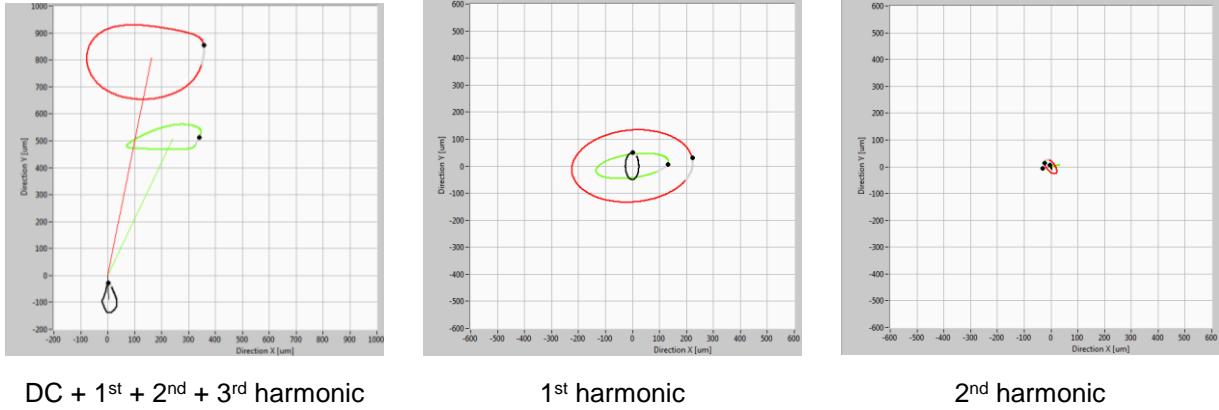
Orbit diagrams for rotation on nominal rotational speed with excitation are shown on Fig. 5 and Fig. 6. Coordinate system's zero position is taken when the unit was in mechanical rotation at nominal rotational speed.

To check on the influence of the excitation on the shaft center position (DC) and vibrations (AC) around this new point – statical shaft position (DC) is included in the orbit diagrams. This is shown on Fig. 5 (before the overhaul) and Fig. 6 (after the overhaul).

Fig. 5 Before the overhaul (July 2015): Orbit diagrams of relative vibrations in the UGB (black), ThrB (red) and TGB (green) planes in mechanical rotation (with excitation). The statical (DC) component is included in the signal. LEFT: synthesized from 1st + 2nd + 3rd harmonics; MIDDLE: synthesized from 1st harmonic (without DC); RIGHT: synthesized from 2nd harmonic of rotational speed (without DC).

When the changes in the orbit center exist – that means eccentricity between the rotor and stator exists and that **Unbalanced Magnetic Pull (UMP)** is generated. This is due to the fact that there exists radially spaced electromagnetic forces between the rotor and stator and they do not all add up to zero. So there is a force vector pointing in the eccentricity direction and it is in this direction that the rotor moves to. This movement is, eventually, counteracted with the forces originating within the bearing. A certain amount of UMP is allowed but should be under control (comparison to the bearing clearance should always be made).

The statical (DC) shaft movement was **much smaller after the overhaul meaning that the eccentricity was significantly reduced**. By how much – can be seen from the air gap analyses (next section).

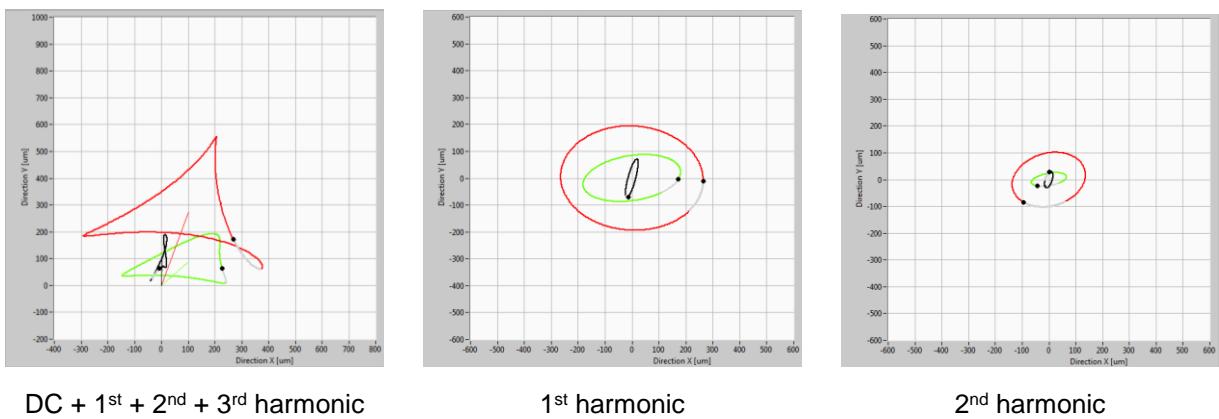
Fig. 6 After the overhaul (August 2016): Orbit diagrams of relative vibrations in the UGB (black), ThrB (red) and TGB (green) planes in mechanical rotation (with excitation). The statical (DC) component is included in the signal. LEFT: synthesized from 1st + 2nd + 3rd harmonics (with DC); MIDDLE: synthesized from 1st harmonic (without DC); RIGHT: synthesized from 2nd harmonic of rotational speed (without DC).

It should be noted that the full scale ranges are the same on both figures (1200 μm) for an easier comparison between the size/ shape/ offset of the orbits.

As for vibrational (AC) part, for data after the overhaul – it can be seen (from orbit diagrams) that the vibrations on ThrB have increased with excitation – both on 1st and 2nd harmonic of rotational speed. The

change on the 1st harmonic indicates the presence of the magnetic unbalance and the change on the 2nd harmonic is, probably, caused by coupling.

Two-plane dynamical balancing, as described, with regards to comparison between mechanical rotation and rotation under excitation would reduce the vibration levels on the UGB and the TGB into zone B according to ISO 7919-5:2005 [3] be and considered acceptable for unrestricted long term operation.

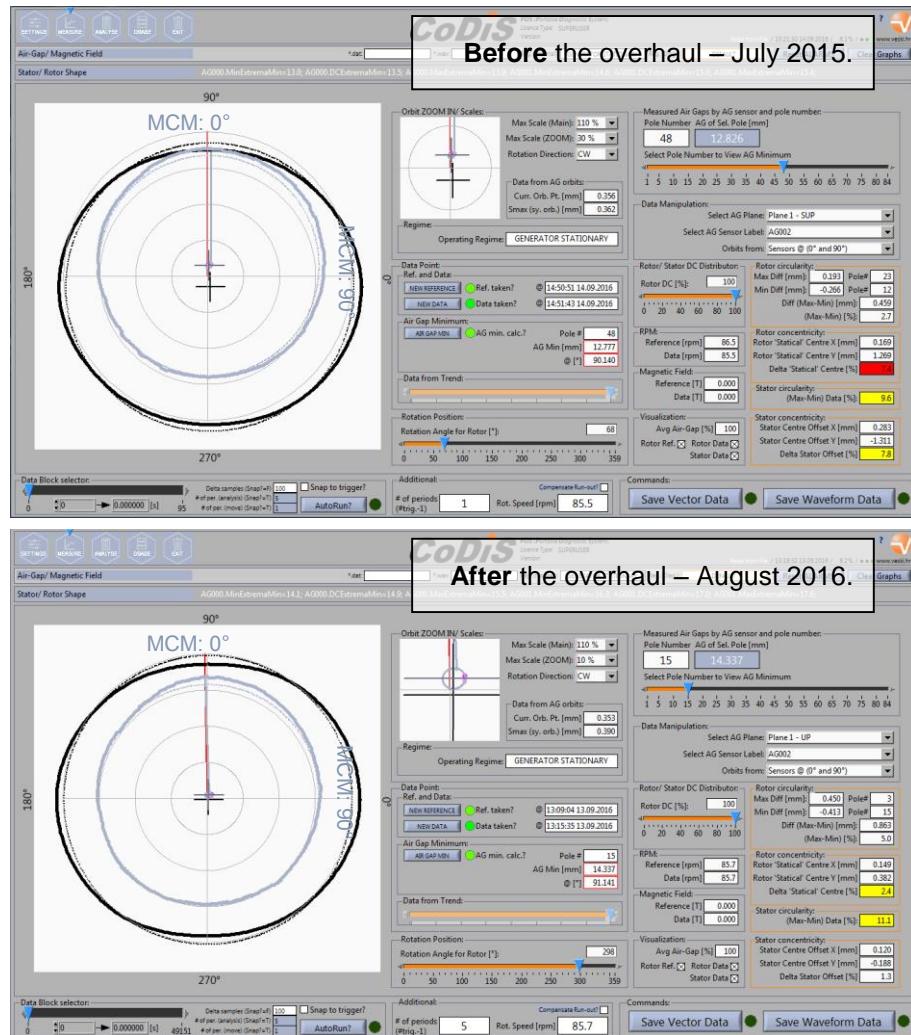
Results from the air gap measurements including rotor and stator polar view are shown on Fig. 7 (from the upper measurement plane). Data before and the overhaul are compared on the figure.

Fig. 7 Polar overview of the rotor and stator geometry in mechanical rotation and after excitation is turned on, compared to the unit's ideal axis (center of the graph). MCM system angles are denoted differently which is indicated in this figure (0° from the analysis corresponds to MCM 90° and 90° from the analysis corresponds to MCM 0°).

UPPER DIAGRAM: Before the overhaul. LOWER DIAGRAM: After the overhaul.

This behaviour is exactly what is seen from the Fig. 7. There exists a certain amount of eccentricity, which is much larger before the overhaul.

The comparison between the two states in the upper air gap measurement plane (near the top of the stator core) is given in the following table (Table 2) and can also be seen from the Fig. 7. Note that the rotor and stator concentricities are referenced to the rotor position (reference).

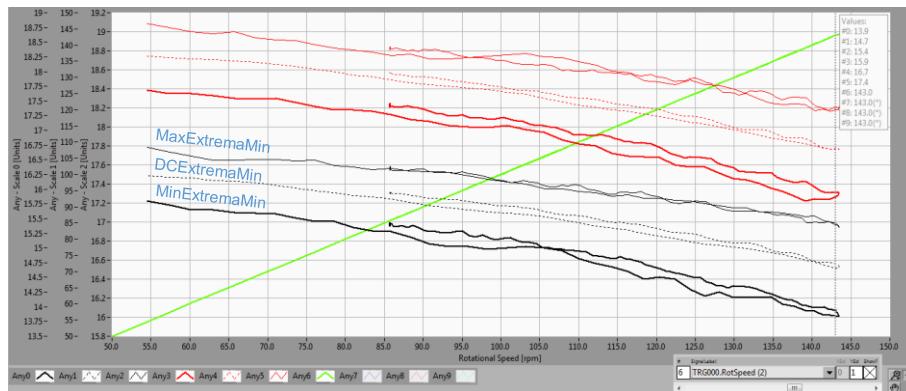
Fig. 8 MinExtremaMin, DCExtremaMin, MaxExtremaMin shown for sensors in **upper** plane (at MCM 0° - black; at MCM 90° - red). Vibrations **not compensated** in the air gap data. Scale 0 is relevant for air gap data. As the speed increases, the MinExtremaMin and MaxExtremaMin lines **move further and further apart**.

Fig. 8 shows the data analyzed for air gap sensors at 90° (black) and 0° (red) MCM labels **without vibration compensation** (raw, as measured) and Fig. 9 shows the data analyzed for air gap sensors at 90° and 0° MCM labels **with vibration compensation** taken into account.

What is seen comparing Fig. 8 and Fig. 9 is that on Fig. 8 the lines (MinExtremaMin and MaxExtremaMin on the same sensor) are not parallel and are becoming further apart when the rotational speed increases. In this case, the reason is that there exist vibrations (precession) of the rotor within the air gap and this precession influences the parameters being calculated. That is – in the air gap signal, there is one part of the signal which is related to the rotor geometry and the other part which is related to the rotor vibrations within the air gap. If compensation for vibrations can be done – this would give a direct insight into the rotor shape (geometry) and how it changes during the overspeed event.

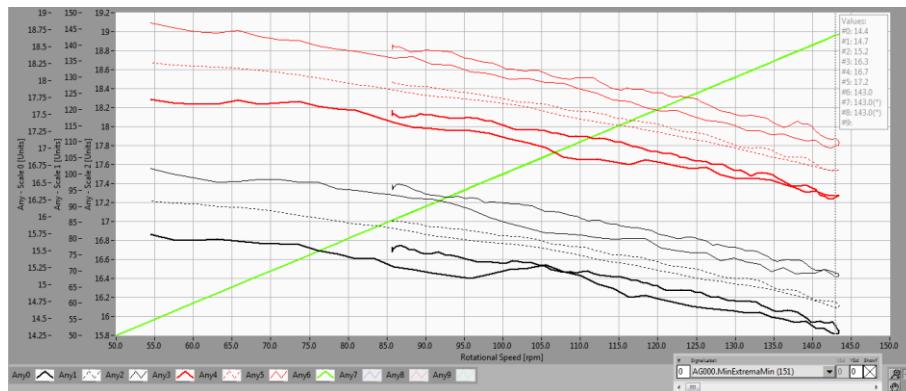
Fig. 9 MinExtremaMin, DCExtremaMin, MaxExtremaMin shown for sensors in **upper** plane (at MCM 0° - black; at MCM 90° - red). Vibrations **compensated** in the air gap data. Scale 0 is relevant for air gap data. As the speed increases, the MinExtremaMin and MaxExtremaMin lines **remain parallel**.

CoDiS-PDS supports this compensation (data on Fig. 9) and it can be seen that the lines (MinExtremaMin and MaxExtremaMin on the same sensor) are, approximately, parallel. This means that the points (poles) on the rotor with the minimum and maximum air gaps extend uniformly and is a direct indication that the **rim extends/ shrinks uniformly up to 143 rpm!**

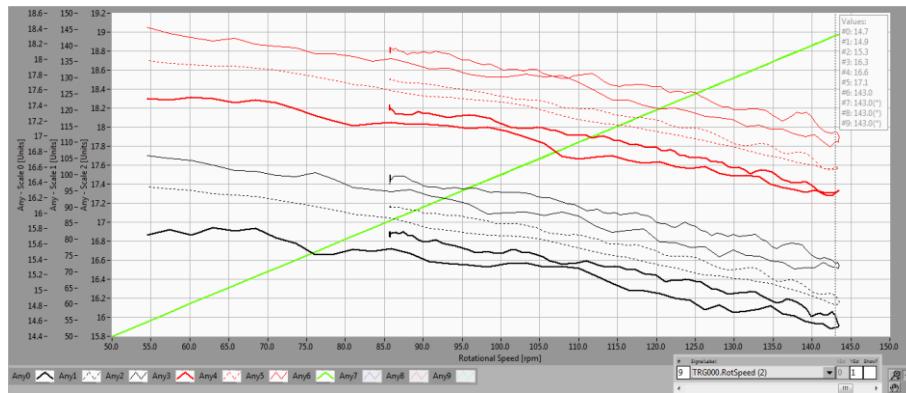
Fig. 10 shows the same data in the lower air gap measurement plane. The results are similar to those shown on Fig. 9.

Fig. 10 MinExtremaMin, DCExtremaMin, MaxExtremaMin shown for sensors in **lower** plane (at MCM 0° - black; at MCM 90° - red). Vibrations **compensated** in the air gap data. Scale 0 is relevant for air gap data. As the speed increases, the MinExtremaMin and MaxExtremaMin lines remain **parallel**.

From 55 rpm to 143 rpm the rotor extends, approximately, 1.4 mm which means that the rotor extends from 0 rpm to 143 rpm for ~1.64 mm. This is **smaller than the 2.1 mm to which the interference between the spider and rim was designed and realized during the overhaul**.

So, at 143 rpm the rotor rim is still in contact with the radial keys on all positions and that's why the rotor extends uniformly on all sensor positions.

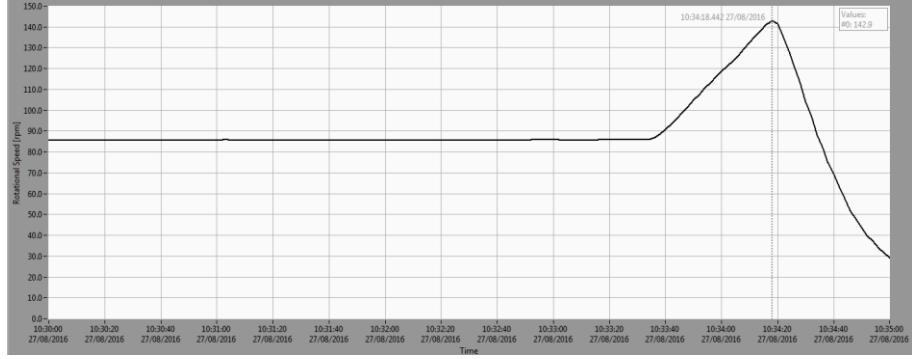
During the overspeed event in mechanical rotation, vibration data was captured for different rotational speeds. The rotational speed trend is shown on Fig. 11.

Fig. 11 Rotational speed trend during overspeed tests (recorded on August 27th 2016).

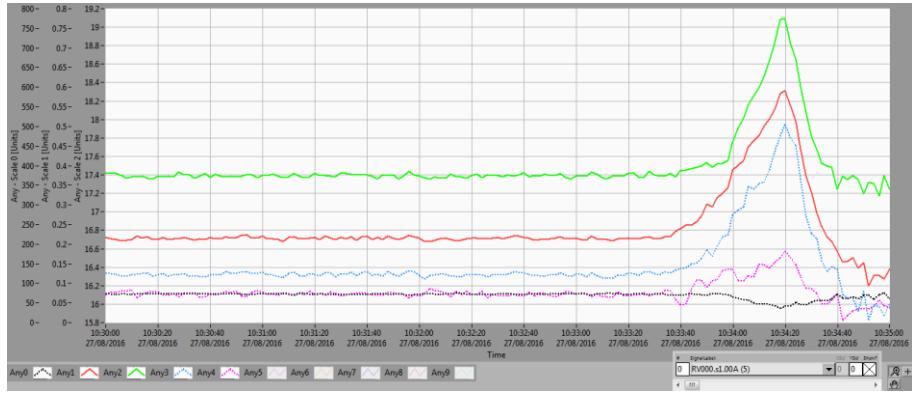
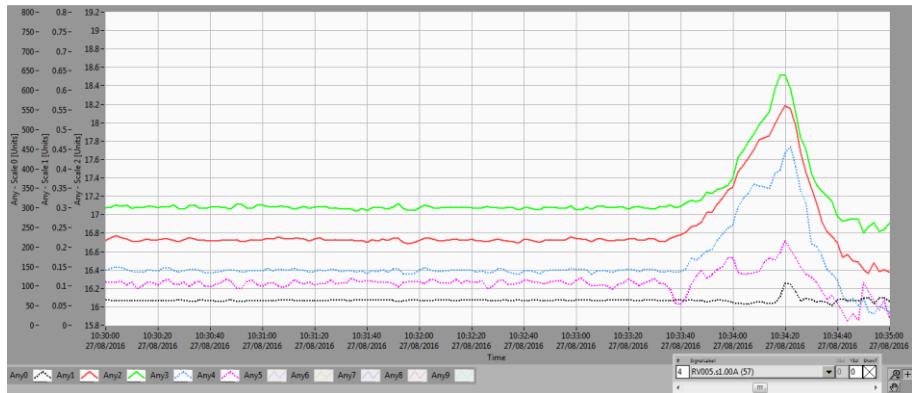
Fig. 12 Direction 0 deg: Amplitude of the first harmonic of rotational speed: UGB – 0 deg [μm] – Scale 0 (black dotted line), AG – UP – 0 deg [mm] – Scale 1 (red line), AG – DOWN – 0 deg [mm] – Scale 1 (green line), ThrB – 0 deg [μm] – Scale 0 (blue dotted line), TGB – 0 deg [μm] – Scale 1 (purple dotted line).

Fig. 13 Direction 90 deg: Amplitude of the first harmonic of rotational speed: UGB – 90 deg [μm] – Scale 0 (black dotted line), AG – UP – 90 deg [mm] – Scale 1 (red line), AG – DOWN – 90 deg [mm] – Scale 1 (green line), ThrB – 90 deg [μm] – Scale 0 (blue dotted line), TGB – 90 deg [μm] – Scale 1 (purple dotted line).

What is visible from those two figures is that, for low rotational speed, vibration within the bearings decrease to relatively small values (~50 μm) which is an indicator that the rotor is aligned correctly, that is, there is a small, but tolerable run-out.

On the other hand as the rotational speed decreases – vibrations within the air gap on the upper plane (red) reach ~0.135 mm (average of both figures) and on the lower plane (green) ~0.303 mm at ~24.3 rpm.

What this means is that the rotor is attached to the spider with a certain amount of eccentricity. The reason for the small (but non-zero) 1x value doesn't originate from the vibrations as the centrifugal forces are small at low speeds and, therefore, the vibrations due to the mechanical unbalance are as well. The reason for the 1x value is eccentricity.

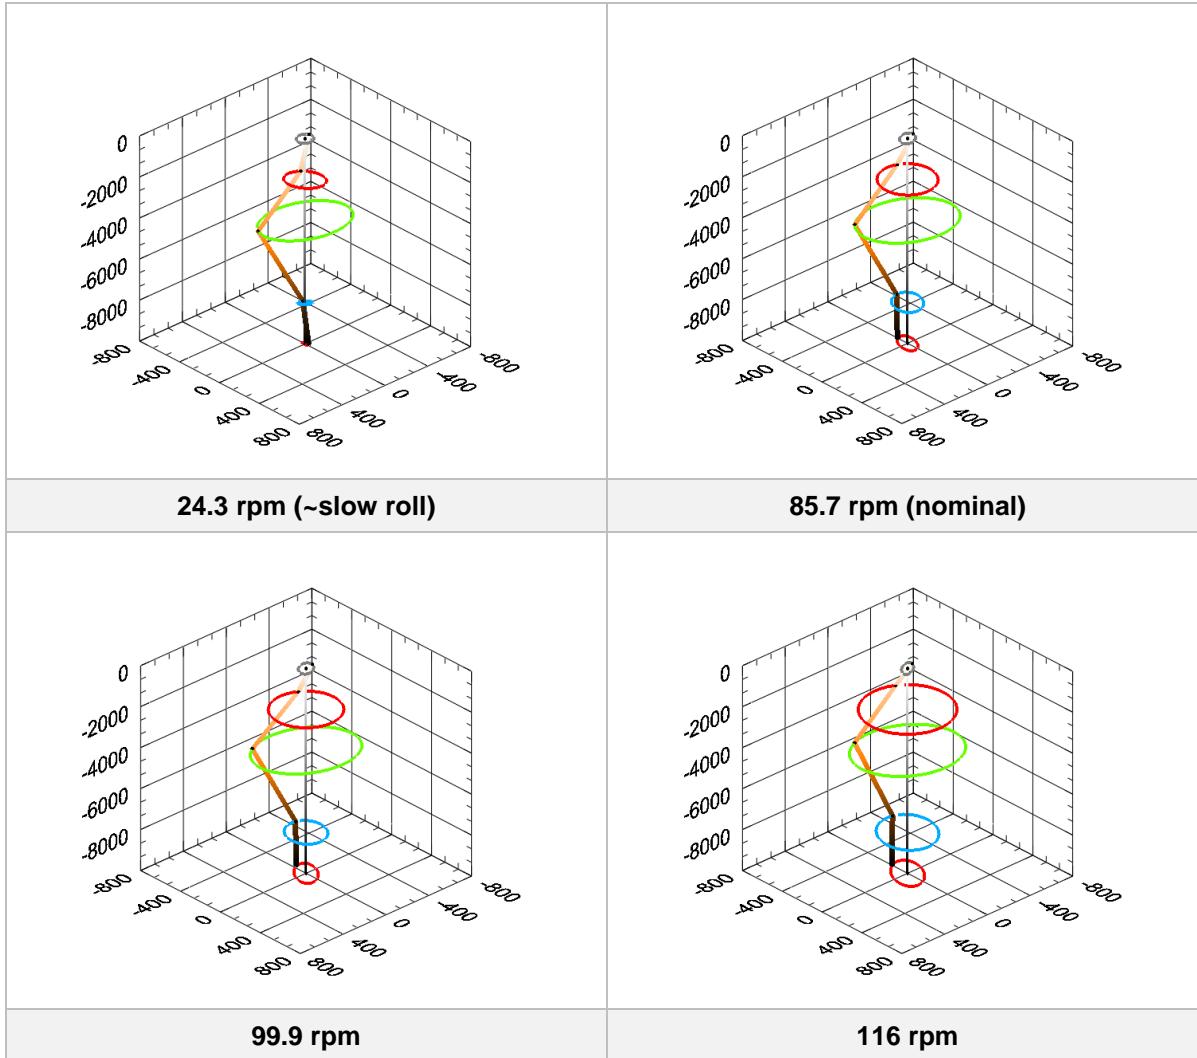
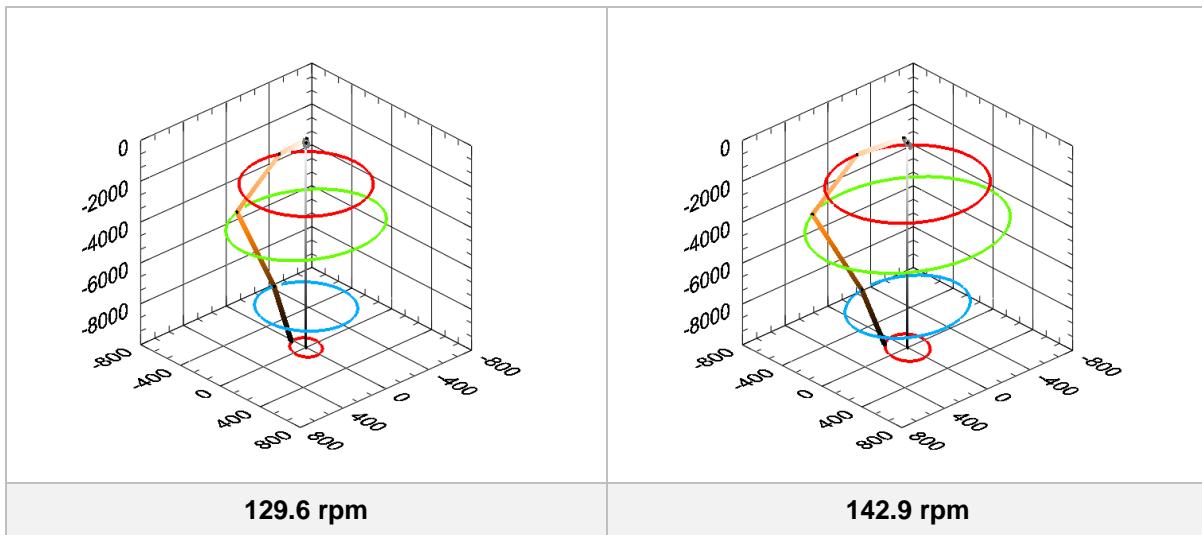
A good way to visualize how the rotor dynamical shape changes with rotational speed is to show it in "3D" (Fig. 14). What is drawn are the 1x orbits for all measured planes – including bearing planes and air gap measurement planes. Using CoDiS-PDS software – vibrations were extracted from the air gap signals and visualized here. The planes are the same as those indicated on Fig. 2 (LEFT).

Fig. 14 3D Dynamical rotor line from data on 24.3, 85.8, 99.9, 116.0, 129.6 and 142.9 rpm. The planes are (UP to DOWN, respectively): UGB, AG – UP, AG – DOWN, ThrB, TGB. Amplitude and phase data from sensors in 0° and 90° directions was used to produce the figures.

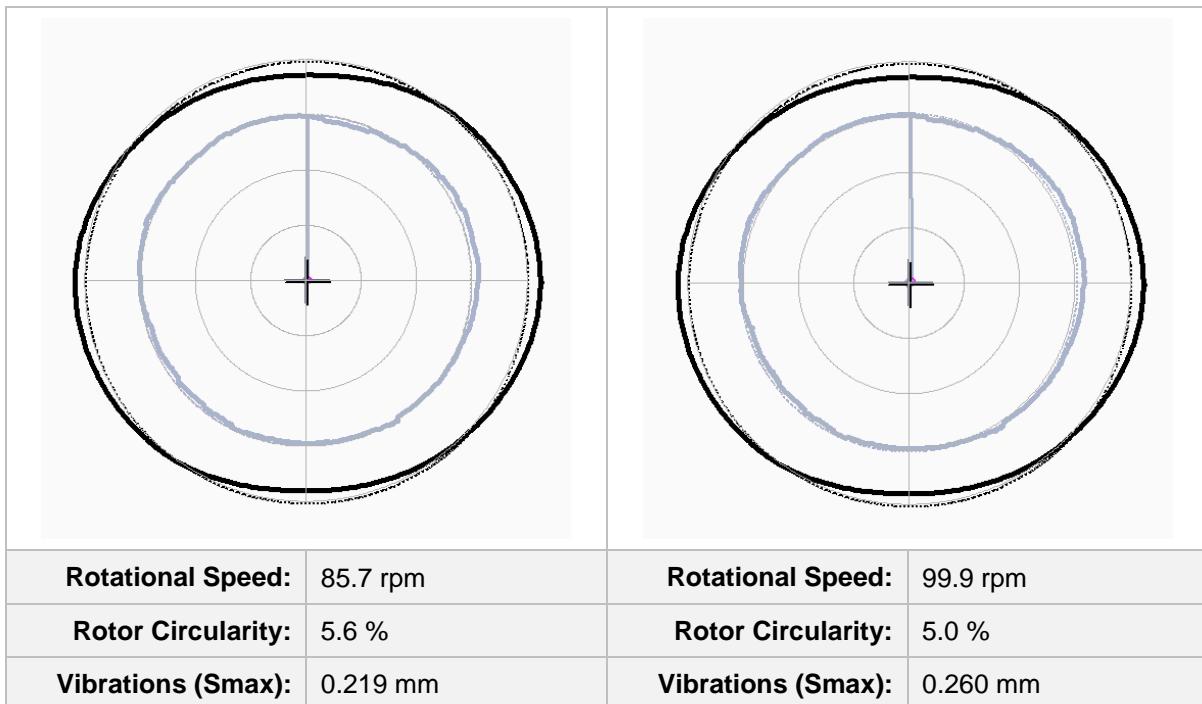
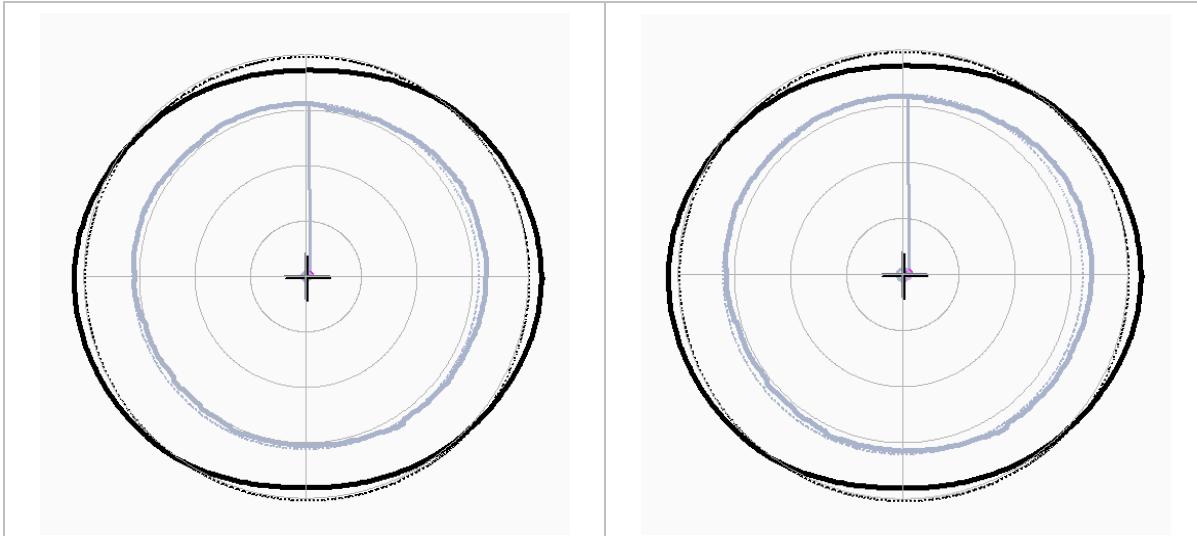
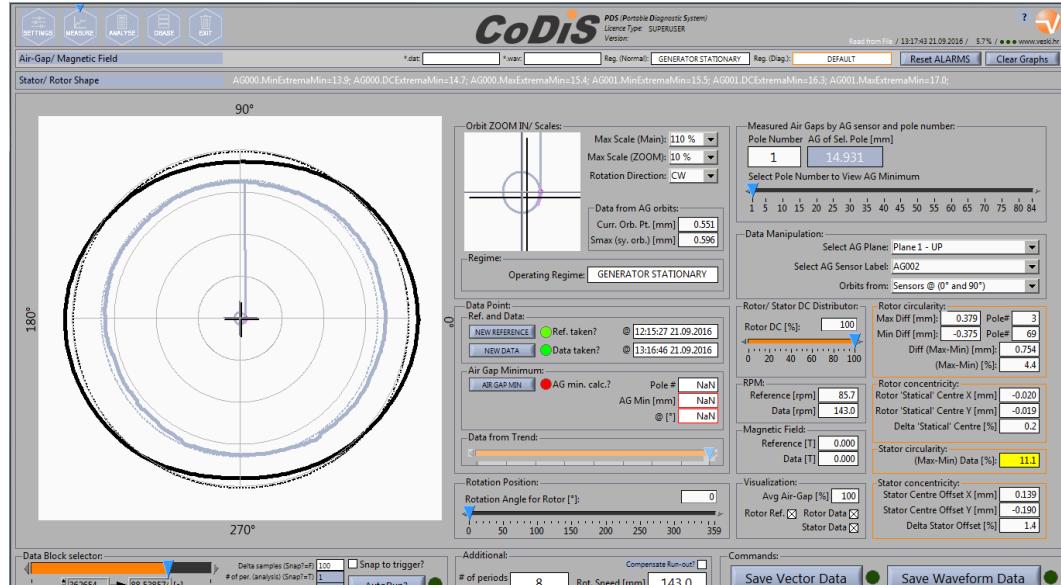
Rotational Speed:	115 rpm	Rotational Speed:	130.3 rpm
Rotor Circularity:	4.7 %	Rotor Circularity:	4.9 %
Vibrations (Smax):	0.340 mm	Vibrations (Smax):	0.470 mm

Rotational Speed:	143 rpm
Rotor Circularity:	4.4 %
Vibrations (Smax):	0.596 mm

Fig. 15 Rotor (and stator) shape during overspeed test. Rotational speed, rotor circularity and vibrations inside the air gap are indicated below each figure. Reference data is taken at nominal speed (85.7 rpm).

From the figure it can be seen how the rotor shape changes from ~5.6 % (at 85.7 rpm) to ~4.4 % (at 143.0 rpm). The vibrations inside the air gap increase from ~0.219 mm (at 85.7 rpm) to ~0.596 mm (at 143.0 rpm).

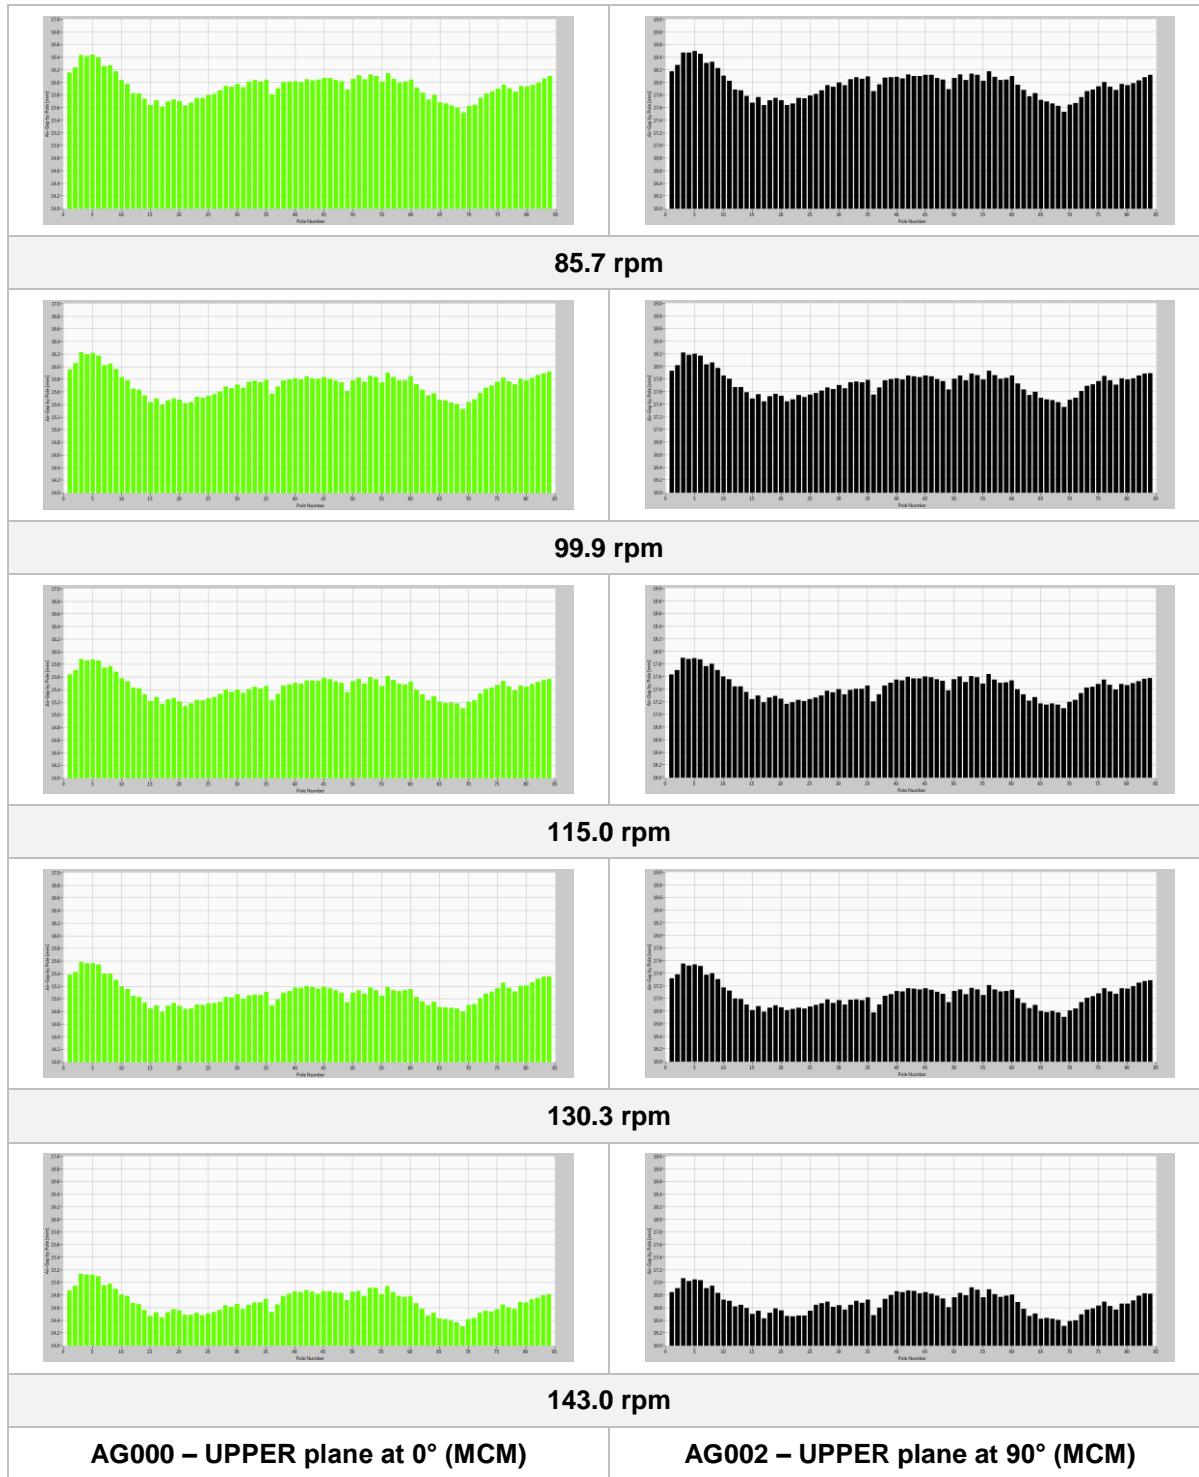
The data for rotor shape is shown as a bar plot for two sensors in the upper plane: AG000 (MCM 0°) and AG002 (MCM 90°) – Fig. 16.

Fig. 16 Bar plots indicating real rotor shape (vibrations compensated in the air gap) for two sensors at upper plane: AG000 – UPPER plane at 0° (MCM) and AG002 – UPPER plane at 90° (MCM).

From the bar plots in Fig. 16 the first thing that can be seen that the air gap reduces (for each pole) when the rotational speed increases. This is due to the fact that the centrifugal force extends the rim radially therefore reducing the air gap. The other thing to notice is that the rotor shape remains roughly the same

for all rotational speeds. When comparing bar graphs for the same sensor at different rotational speeds it is seen that the same shape shifts indicating that there are no rim sections which extend more than the other.

Therefore – the rim extends/ shrinks uniformly for an overspeed event up to ~143 rpm.
