# LOOSE STATOR CORE DIAGNOSTIC METHODS

## SUMMARY

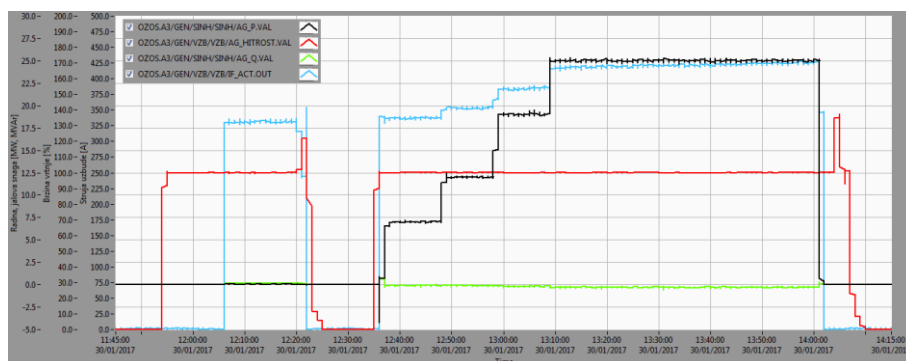
**Fig. 12 Process parameters from SCADA system. Active power – black (first Y axis), rotational speed – red (second Y axis), reactive power – green (second Y axis), excitation current – blue (third Y axis).**

It is important to note that while the regimes were changing up to ~13:10 h, after that time they remained unchanged from (~13:10 h to ~14:00 h). The unit operated at ~25 MW with small amount of reactive energy (practically zero).
