VIBRATION DIAGNOSTICS AND OVERHAUL PROCEDURES IN HPP JAJCE 1

Problems related to large vibrations were observed in Jajce 1 Hydro Power Plant on Unit 1. Extensive vibration measurements were conducted with the purpose of providing clear guidelines for the unit overhaul. Vibration was monitored in all relevant operating regimes.

Two Francis turbine powered hydro units, 31 MW each are installed in Jajce 1 Hydro Power Plant. Net head is 92.5 m and the rotational speed 300 rpm with the 37 m³/s flow per unit. Very large vibrations have been noticed on Unit 1. For this reason – measurements to reveal the vibration root causes have been performed and adequate overhaul procedures suggested. Accurate measurement results interpretation and problem diagnostics are of crucial importance for successful overhaul works to reduce the unit vibrations.

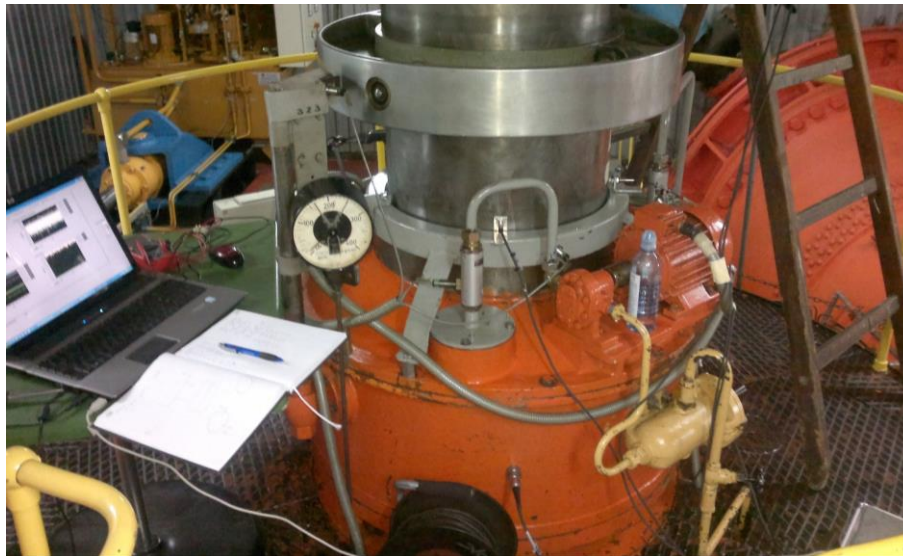
Fig. 3 Sensors at TGB along with the laptop used for measurements.

The bearings are: UGB – Upper Guide Bearing, LGB – Lower Guide Bearing and TGB – Turbine Guide Bearing. The thrust bearing is of the combined type and is integrated with the UGB into one housing. Fig. 3 shows the sensors at TGB level along with the laptop used for the measurements.

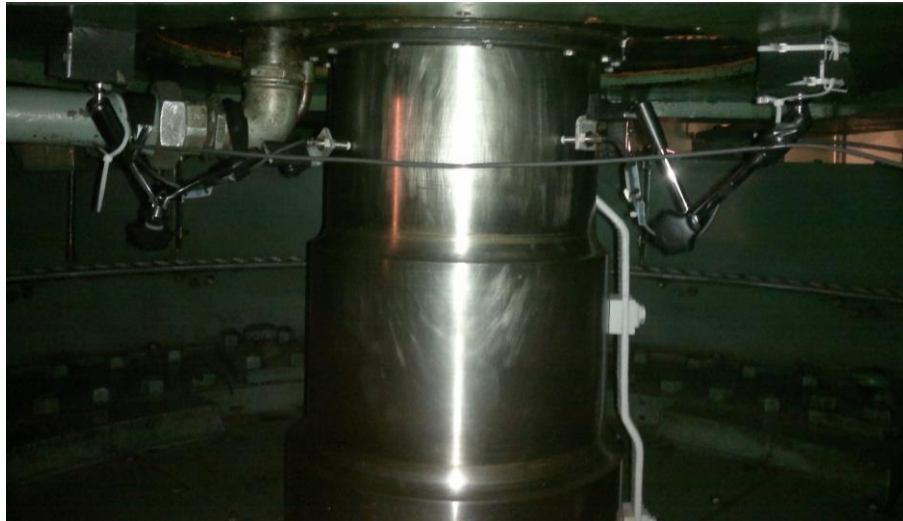
Fig. 4 Sensors under UGB (and under the thrust collar).

Additionally, for the measurements in which the rotor dynamical line was established – the sensors were placed in different planes along the unit's vertical (axial) direction. One example is given on Fig. 4 (for sensors placed under UGB under the thrust collar).

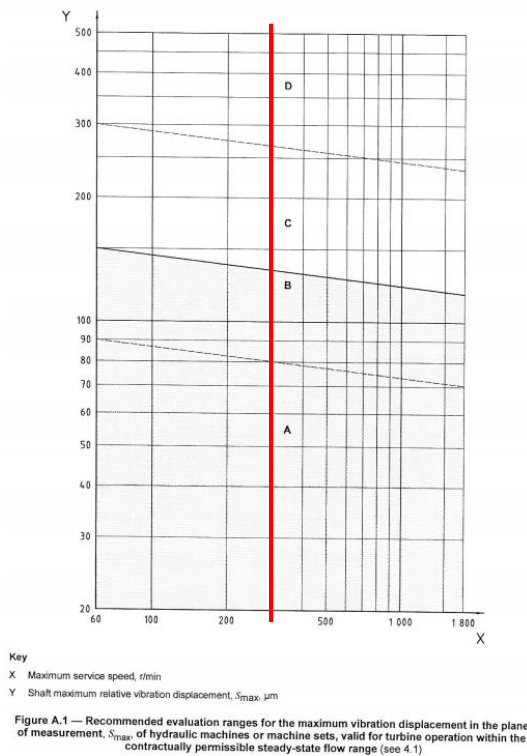
From Fig. 5 it can be seen that the LGB relative vibrations in both directions X and Y are outside the allowed values recommended by the standards (ISO 7919-5:2005 – see Fig. 6) and also outside the one-sided clearance which is set to ~0.22 mm. For example – the boundary between zones C/D¹ for 300 rpm machines is at 270 μm and the amplitude peak vibrations on LGB are above 700 μm ! It would be very dangerous to run this machine for a longer time as it could lead to its catastrophic failure.

Note that the 700 μm is even above the diagram visible area (Fig. 6)!

¹ Zone D: Vibration levels in this zone indicate that there is a high probability of damage to the machine. For this reason – immediate action is required to identify the reasons for the high level of vibration.

Fig. 6 ISO 7919-5 standard for relative shaft vibrations. Zones of operation based on S_{max} are shown. Rotational speed for HPP Jajce 1 is indicated.
