CASE STUDY – 03

Hydrogenerator stator and rotor eccentricity

Problem: Detected large stator and rotor eccentricity

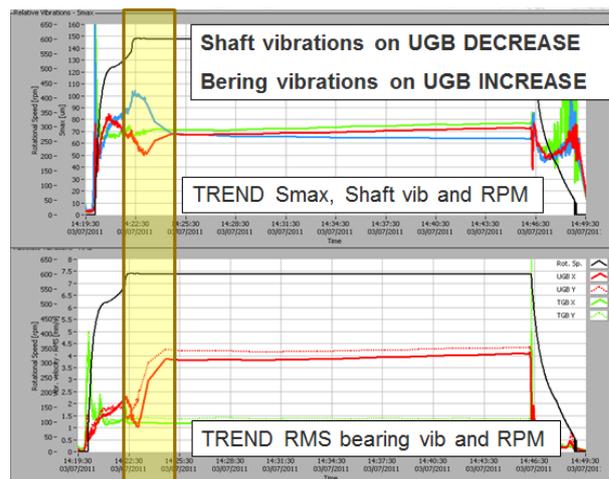
The conclusion of the Veski experts was that vibration problems occur from the stator and rotor being eccentric which creates the static magnetic pull with field flashing. This was verified with CoDiS Air Gap monitoring module as shown on page 1. The pull is creating the load on that part of the bearing leaving the shaft no space to vibrate and making the oil film very stiff.

This is also visible in absolute bearing vibration measurements which increase from 0.75 mm/s to 4 mm/s with field flash whereas relative shaft vibrations decrease due to lack of space to move inside the bearing.

This load on the bearing was the reason for the cracked seal and oil leakage that was occurring repeatedly over the years.

The plant personnel needed to conduct serious refurbishment that would include stator shifting to minimize the eccentricity and reduce the magnetic pull force.
